MOONEY AIRCRAFT, INC. (FAA Approved)

This Service Letter reidentified as
Service Bulletin M 20-100
per Service Instruction M20-15.

SUBJECT: Inspection and Rework of Skin Joint, Wing Station 59.250

MODELS AFFECTED: M20B, Serials 1702 through 1763, except for the following numbers:
1703, 1708, 1709, 1710, 1711, 1715, 1730, 1731, 1750, and 1759

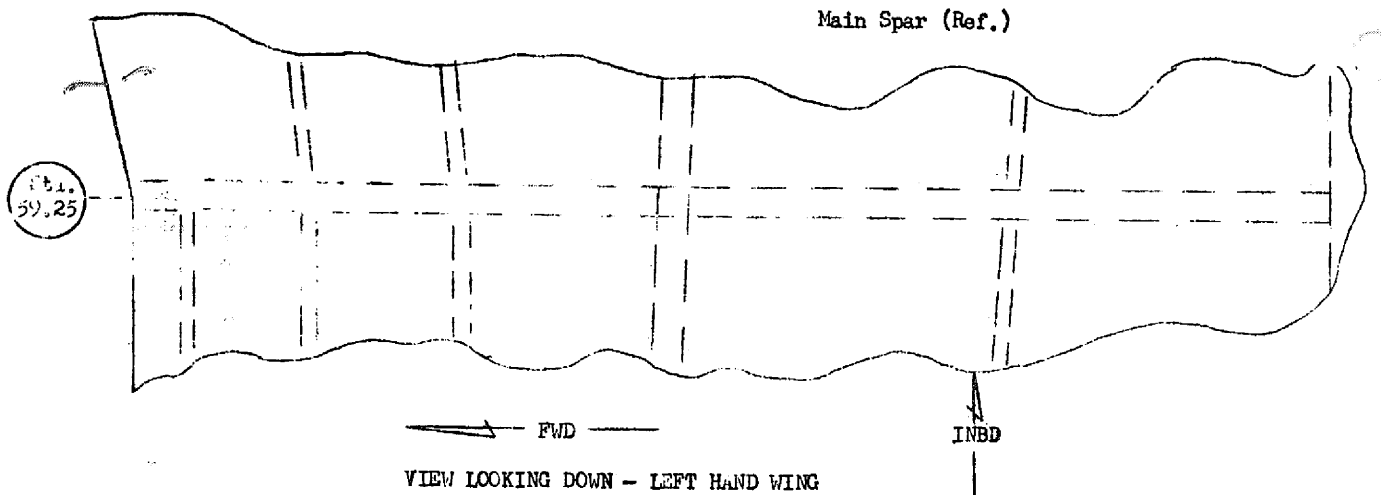
FIGURE 1

Inspect the rivets in the areas shown on Figure 1 for signs of loosening. Loose rivets are characterized by black oxide which seeps between rivet and skin to the surface. This oxide may leave a slight streak in the direction of the air stream if the rivet has been loose for some time. In any event, if black oxide is present, it will be noticeable by simply passing a finger or white cloth over the head of the rivet.

Paint cracks around the head of a rivet are not necessarily indications of a loose rivet. These paint cracks may occur due to the normal amount of dirt which may be present at the time the rivet is installed, or from solvents used in preparation prior to painting. Only if the black oxide described above is present is the rivet considered loose.

A maximum of four (4) loose rivets per side in the specified areas will be considered acceptable with no rework necessary. However, it will be necessary to continue this simple inspection every fifty (50) hours or so to assure that no additional rivets become loose. The inspection need not be continued after the rework described below has been accomplished.

If and when more than four rivets per side are found to be loose, all of the rework described below is to be accomplished on that wing. It is considered that the rework on both wings as described is desirable in order to avoid continuing inspection of any area not reworked as well as avoid further inconvenience to the owner due to a later repair.

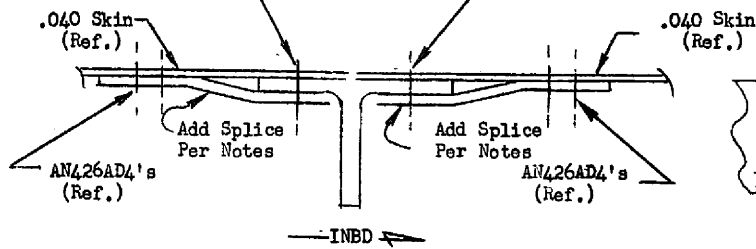
FIGURE 3
(Section C-C)
Area 3

Replace AN426AD4's with AN426AD5's as per Par. C.II.

Replace AN426AD5's with AN426AD6's as per Par. C.II.

II. Area 3 (Aft of the Main Spar) Ref. Figure 3

Add splices to each side of the upper rib cap as shown. Loose rivets are to be replaced with the next larger size (AD5's with AD6's and AD4's with AD5's) provided that a center-to-center spacing of at least .62 inches exists between AD6's and .50 inches exists on AD5's. If the distance is less than these values, replace with existing rivet size.

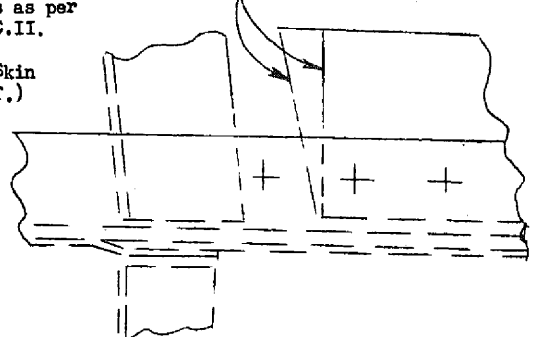
FIGURE 4
(VIEW D-D)
(Typ.)

Optional Trim Line For Splice Plates

- III. If an edge distance of 2D on rivet at ends of splice adjacent to stringers cannot be maintained, trim end(s) of formed splice such that 2D edge distance on second rivet from stringer can be maintained. See Figure 4.
