MOONEY AIRCRAFT INC.
KERRVILLE, TEXAS
SERVICE LETTER 20-17

SERVICE BULLETIN M-20-17

DATE: 11-20-56

SUBJECT: Kit-Spacer Bushings - Hook Latch

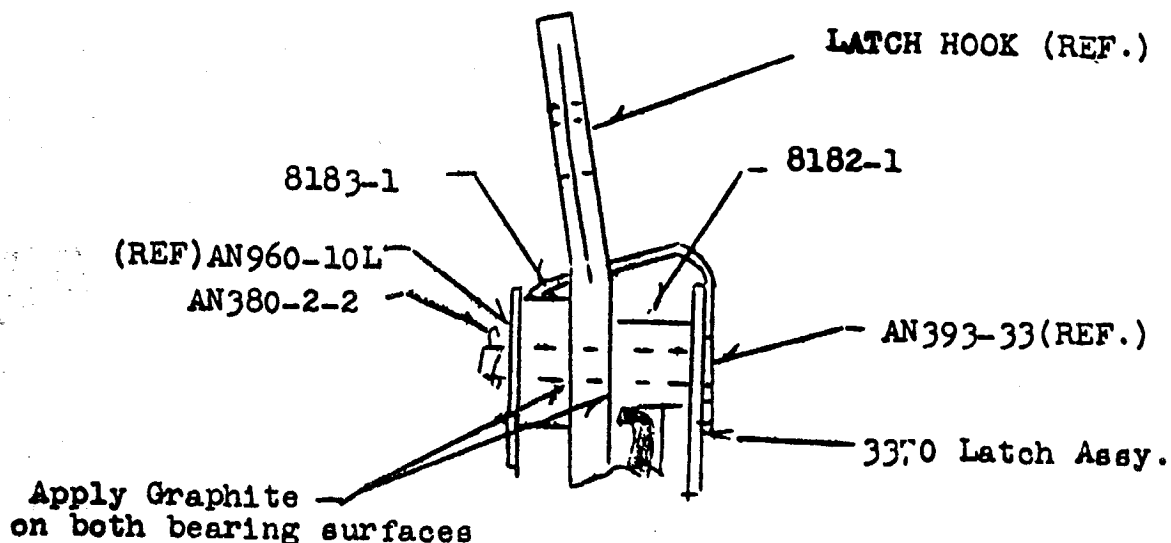
Figure 1

Several cases have been found where normal wear has caused excessive play to develop in the latch hook on the cabin door, permitting the hook to ride over or under the door opening frame. This can result in damage to the hook. To reduce wear and play the small bushings and washers used on the latch assemblies of the models affected are now being replaced on the production line with bushings having a larger bearing surface. These bushings are enclosed without charge for installation on units in the field.

Remove sheet metal screws attaching latch cover plate to door and two machine screws under door gasket. This should allow the latch to be pulled down far enough to remove clevis pin through slot in latch hook (Figure 1).

Remove and discard the two bushings and washers spacing the latch hook. Install enclosed bushings as shown. Replace Latch assembly with the two machine screws and replace sheet metal screws in cover plate. Replace upholstered panel and screws in upper part of window molding.
