SUBJECT: LANDING GEAR SAFETY SWITCH OVERRIDE

MODELS AFFECTED: M20C 700055 thru 20-1233
 M20E 700035 thru 21-1180
 M20F 700038 thru 22-1441
 M20J 24-0001 thru 24-0237

Airplane Flight Manual Supplement Models M20C, E, F, J

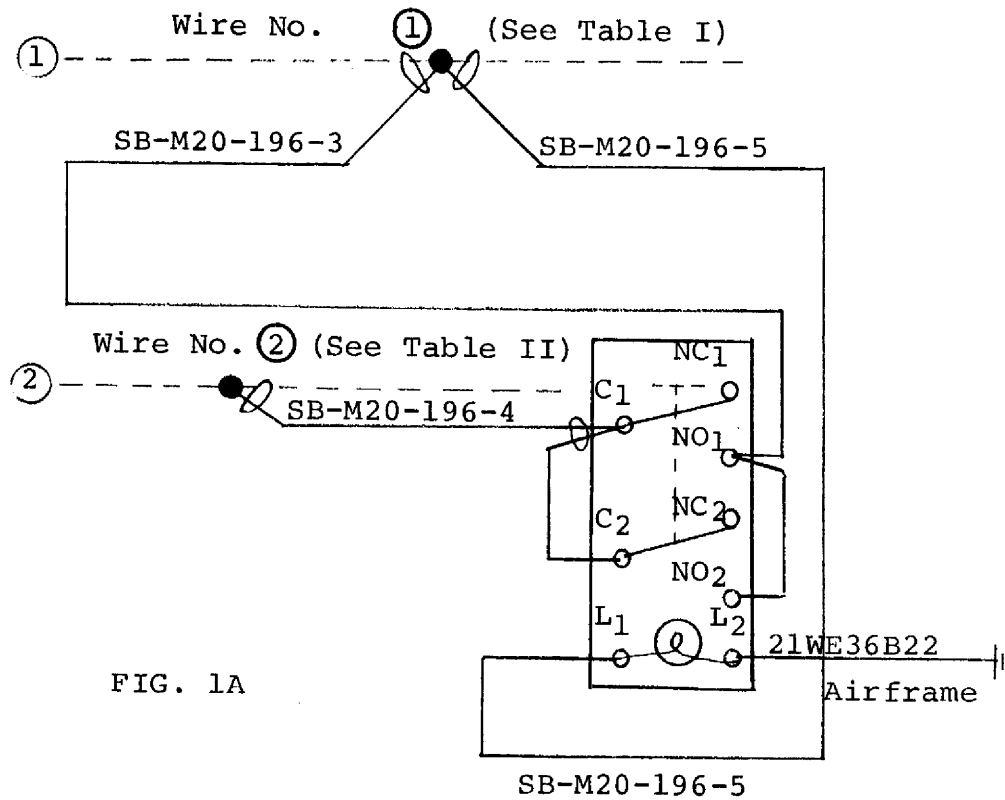
FIG. 1A

For those aircraft with a single relay system that have not been modified as per Service Instructions M20-34A or M20-34B, the following change needs to be followed:

Wire No. (SB-M20-196-5) and wire no. (SB-M20-196-3) are to be installed together at wire no. ①
