**THIS BULLETIN IS FAA APPROVED FOR ENGINEERING DESIGN****SUBJECT: INSPECTION OF FUSELAGE TUBULAR STRUCTURE****MODELS**

AFFECTED: Part A only All M20 Series aircraft manufactured prior to Jan. 1, 1976 excluding S/N's listed under Part B.

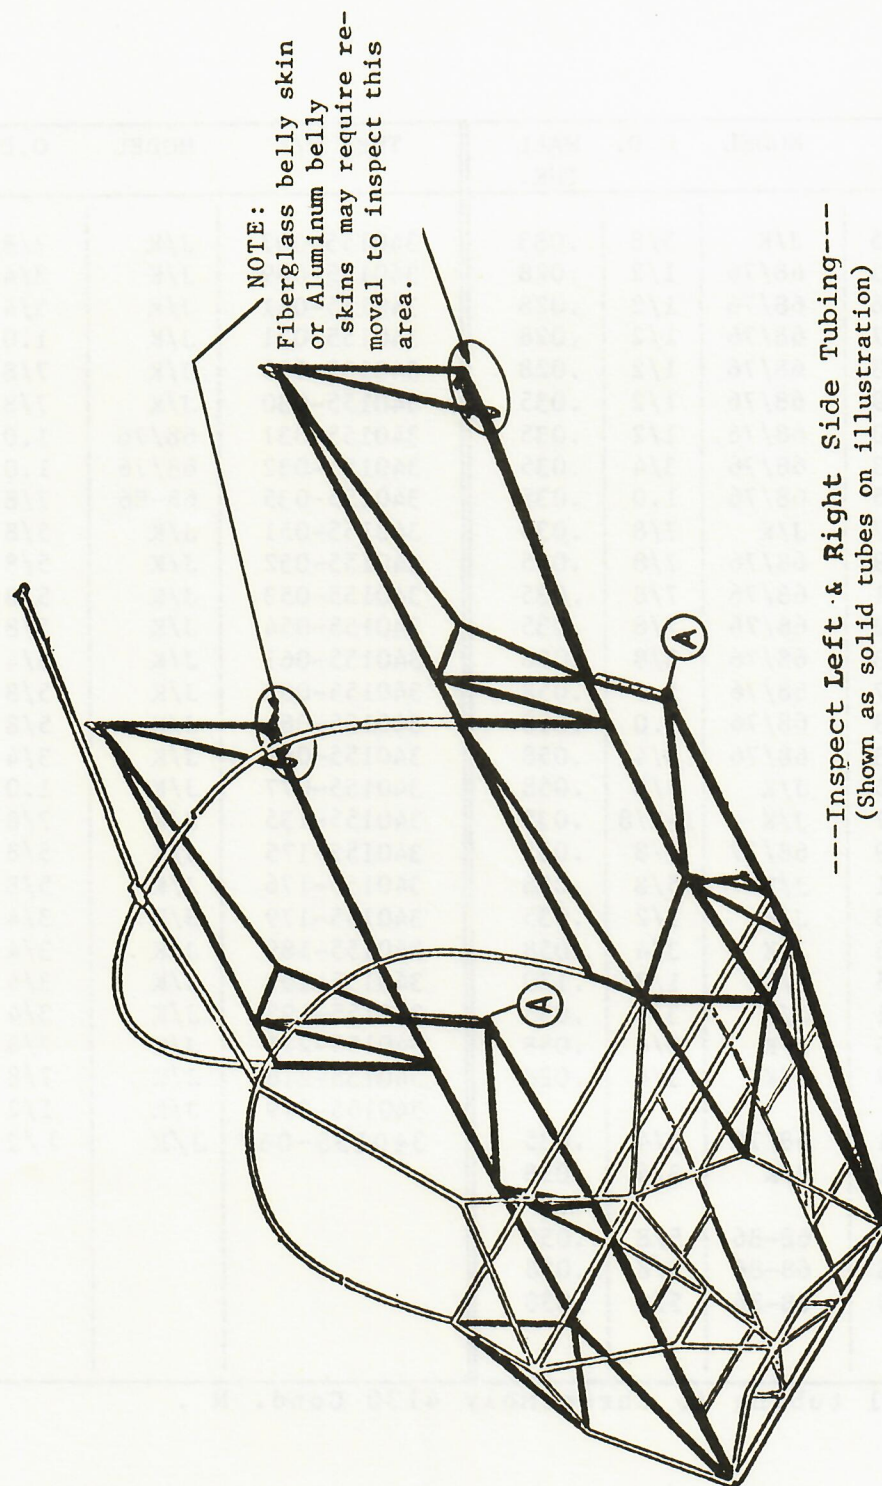
FIGURE S.B. M20-208-2

8. Visually inspect tubes and weld joints for signs of corrosion or moisture (ref. Fig. S.B. M20-208-1 for tubes to be inspected). Special attention should be directed to areas where the insulation was in direct contact with tubular structure members.
9. Use an awl, screwdriver or sharp punch to probe suspect tubes at points of insulation contact, and/or on bottom and lower ends of vertical structure, (where water most likely would be located, if present) to determine if tube wall has corroded from the inside. Probe along the entire length of horizontal tubes and around the circumference of any vertical or angled tube at lower end. Repair or replace any tube where internal corrosion is found. Refer to AC 43.13.1 (*) for recommended testing and repair for welded tubes.

14. Cut safety wire that holds tension bolts. AN7H-17A, located at (A), Figure S.B. M20-208-1.
