SUBJECT: SEAT LIMIT STOPS

AFFECTED: M20J S/N 24-0361 thru 24-0387,
24-0389 thru 24-0394,
24-0396 thru 24-0403,
24-0405 thru 24-0412,
24-0414, 24-0416,
24-0418 thru 24-0422,
24-0424, 24-0425,
24-0427 thru 24-0430,
24-0432, 24-0434,
24-0435, 24-0433

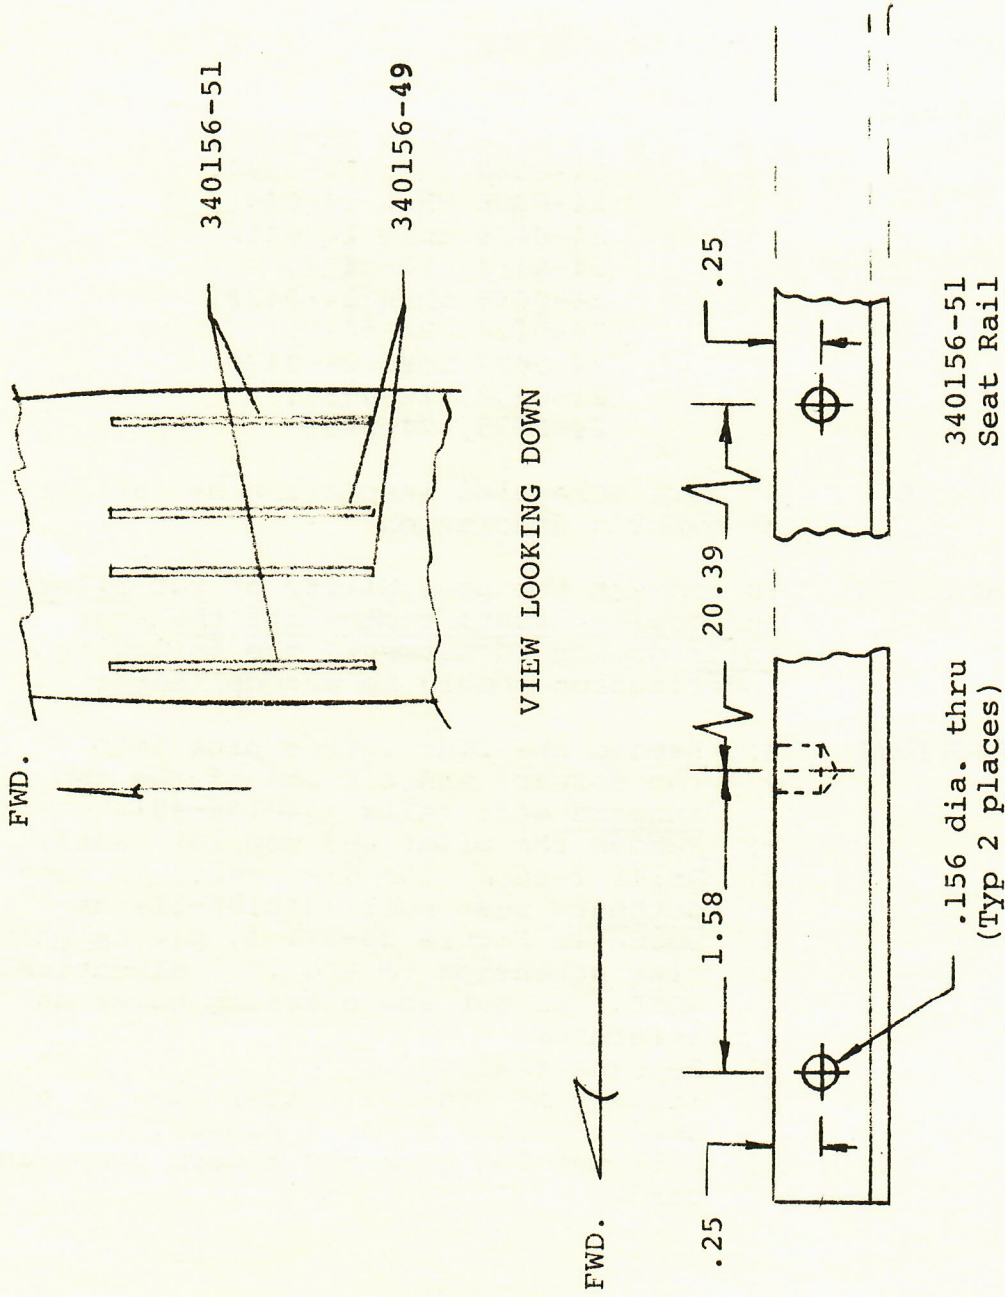
FIGURE 20-211-1

INTRODUCTION: To prevent the possibility of the pilot
and copilot seats coming off the seat
rails during adjustment, the following
modification should be accomplished:

- a) Remove the four cotter pins from the forward and aft end of the two inboard seat rails (340156-49).
- b) Remove the pilot and copilot seats.
- c) Drill 2 each .156 dia. holes in each outboard seat rail (340156-51) as shown in Figure 20-211-1, paying particular attention to the .25" dimension.
NOTE: Do not use existing holes as reference.
- d) Replace seats.
- e) Install AN 380-5-3 cotter pins in each newly drilled hole, 4 places.
- f) Fill out log book and return compliance card.
