SUBJECT: ENGINE TURBOCHARGER OIL PRESSURE INLET CHECK VALVE, TELEDYNE CONTINENTAL MOTORS (TCM) P/N 642211

MODELS/SERIAL NUMBERS AFFECTED: Model M20K - S/N 25-0001 thru 25-0447

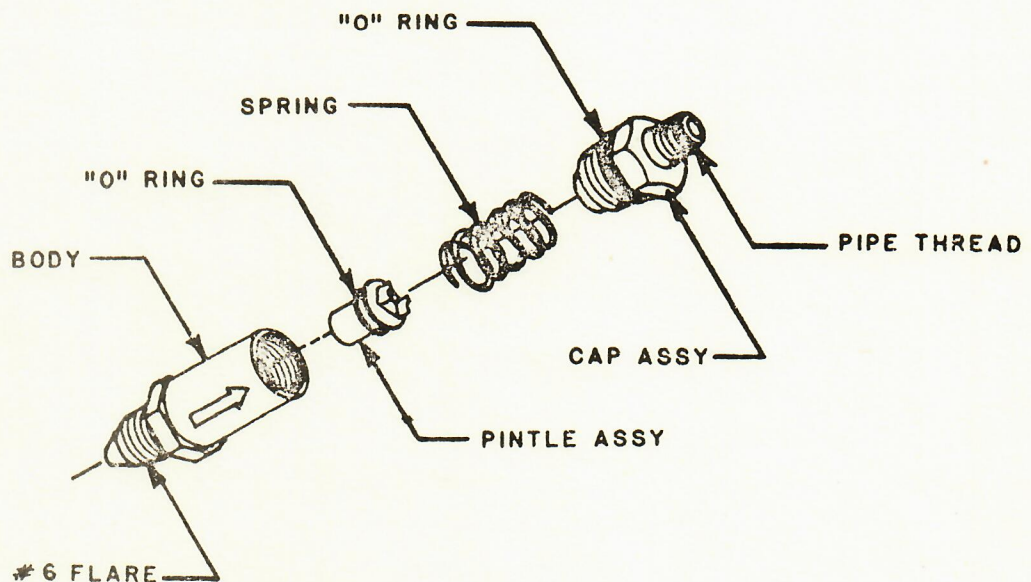
FIGURE 1

INTRODUCTION: It has been determined that in some instances during installation of the subject check valve the recommended torque values may have been exceeded. Replacement of the pipe thread end of check valve is required per this Service Bulletin. This S.B. is to be done in conjunction with TCM S.B. M80-19. Warranty claims to be filed with TCM distributor for **all parts** and one (1) **hour labor** allowance to accomplish **both bulletins**.

3. Place check valve, P/N 642211, in vise or clamping device. Clamp the hex portion at the flare fitting end with arrow on check valve pointing straight up.

4. Remove the pipe thread fitting end cap assy by turning hex portion on that end of valve with wrench.
5. Install new cap end and "O" ring assy, TCM P/N 643825, after coating threads of cap body with engine oil. Torque to body of check valve with 55-60 inch lbs. The new cap end will be blue color for identification.

6. Reinstall complete check valve assy to the 45° fitting on turbocharger after coating pipe thread end with engine oil. Torque unit 60-80 inch lbs. into the 45° fitting. Be careful to prevent any bending or torsional loads to the pipe thread end.

7. Attach the hose and tighten while holding the check valve with wrench to prevent bending or torsional loads being transmitted to the pipe thread end. Torque this flare nut 75 to 125 inch lbs.
