SUBJECT: Inspection of Fuel Tank Sealant Application

MODELS/ M20B, M20C, M20D, M20E, M20F, M20G & M22 — ALL SERIAL NUMBERS.

Airworthiness Directive 85-24-03 Summary

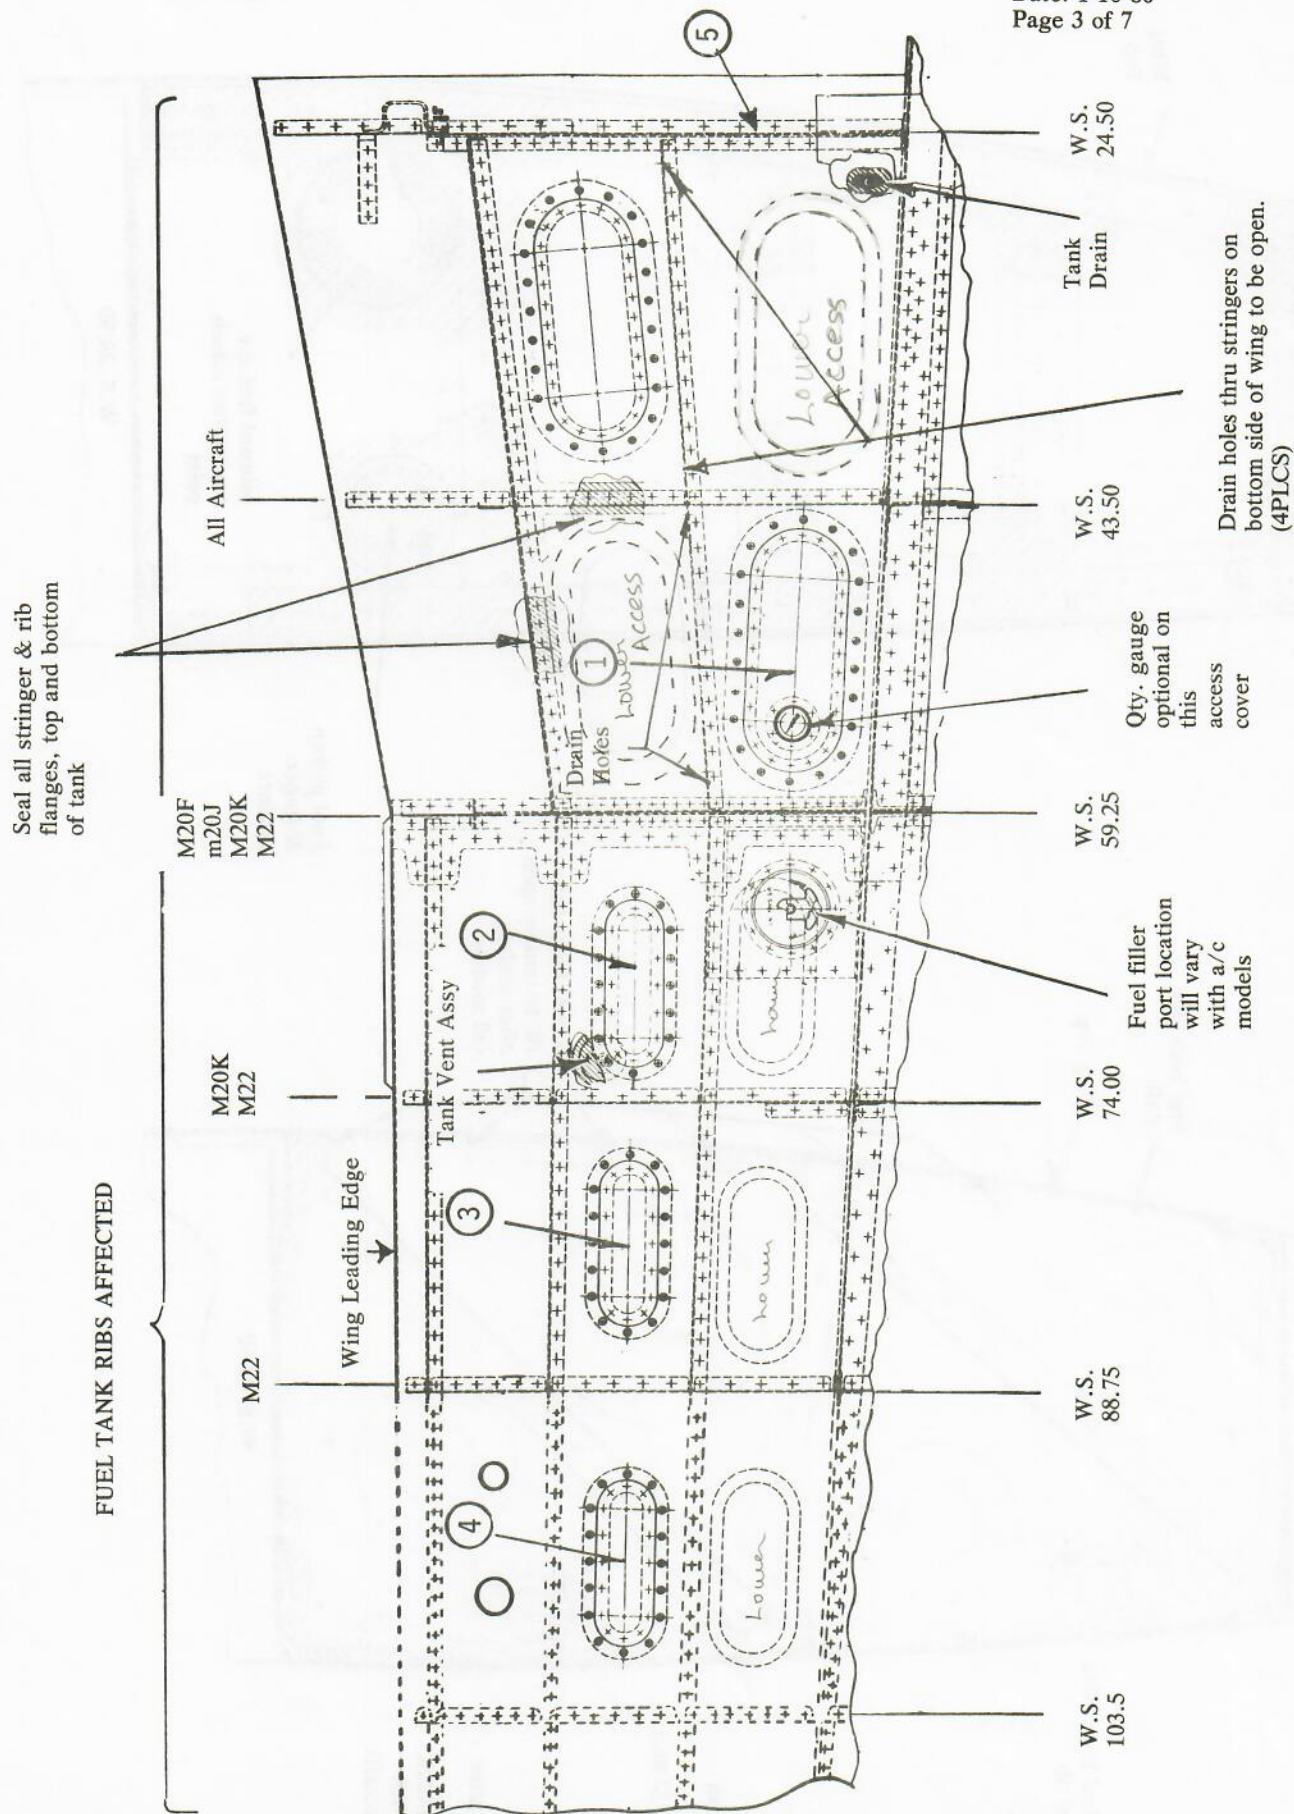
FIGURE M20-230-1
(VIEW LOOKING DOWN FROM TOP OF WING)

A. M20B, M20C, M20D, M20E and M20G Models:
Access Cover No. ① required, Fuel Transmitter ⑤ optional.

B. M20F and M20J Models:
Access Cover No. ① required, No. ② & ⑤ optional.

C. M20K Model:
Access Cover No. ① and ③ required, No. ② & ⑤ optional

D. M22 Model:
Access Cover No. ① and ③ required, No. ②, ④ & ⑤ optional.

1. Position airplanes in an approximate level attitude (all axis) on its landing gear. Drain fuel per instructions in applicable Service and Maintenance Manual.
2. Carefully remove fuel tank access covers on top of wing as indicated below for a particular model (reference Figure M20-230-1).

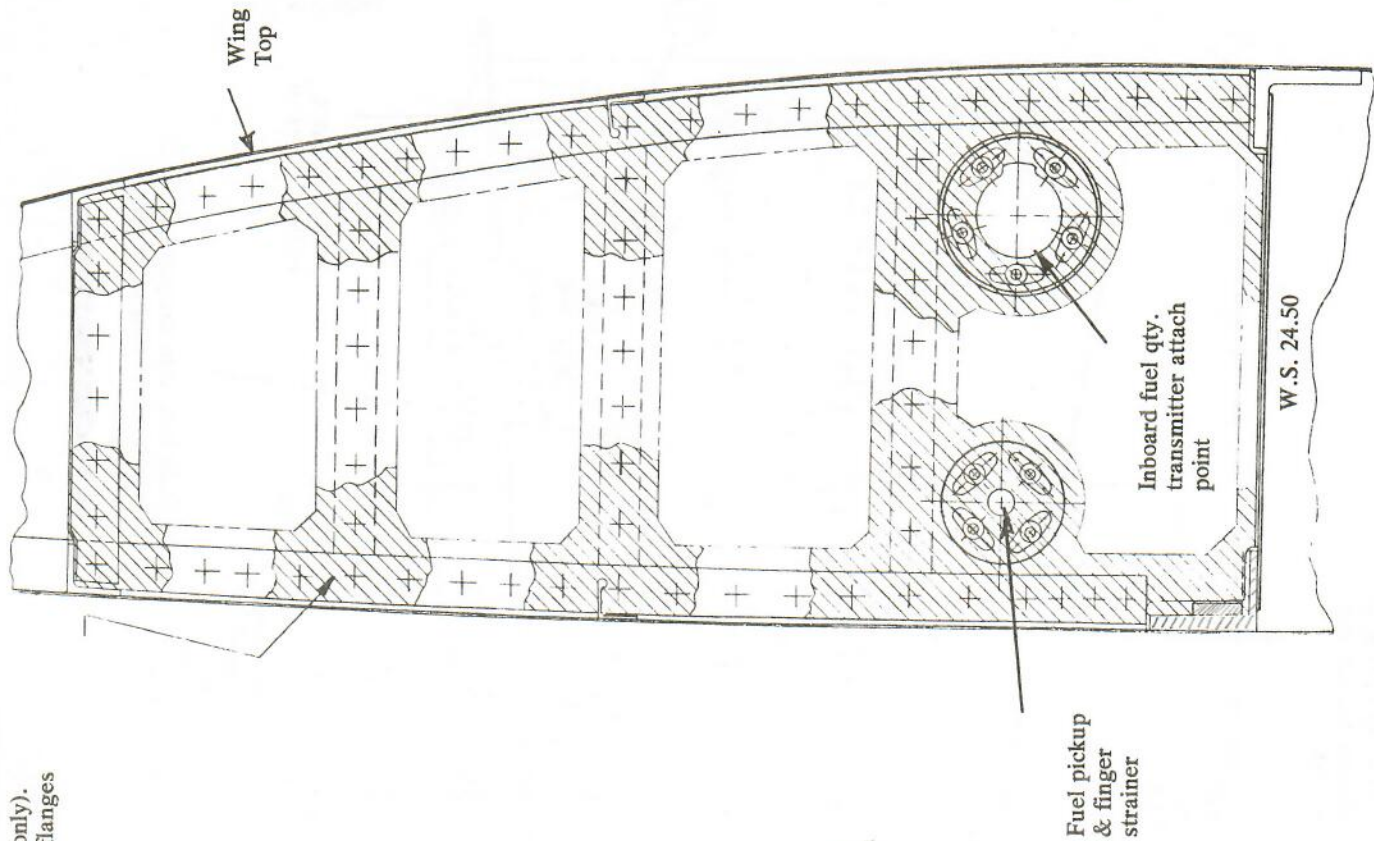
FIGURE M20-230-2

4. Inspect each rib station (refer to Figure M20-230-2 thru -7) to determine that all fuel passage holes are open to allow fuel to drain from outboard of rib stations to the fuel tank sump area.

Seal rib as shown (this side only).
 Seal all rivets, nut plates & flanges
 (ALL MODELS).

7. If inspection determines all holes are **NOT OPEN** in the appropriate ribs as shown in Figure M20-230-2 thru -7 proceed as follows:
 - A. Determine exact position of rib hole(s) that are sealed over.

- B. Using pointed exacto knife clear hole of sealant; be careful not to cut sealant from rib flange.

C. If after clearing hole it appears that fuel can get under adjoining sealant carefully, carefully reseal area without covering hole. use PRI422B½ or B2 sealant.

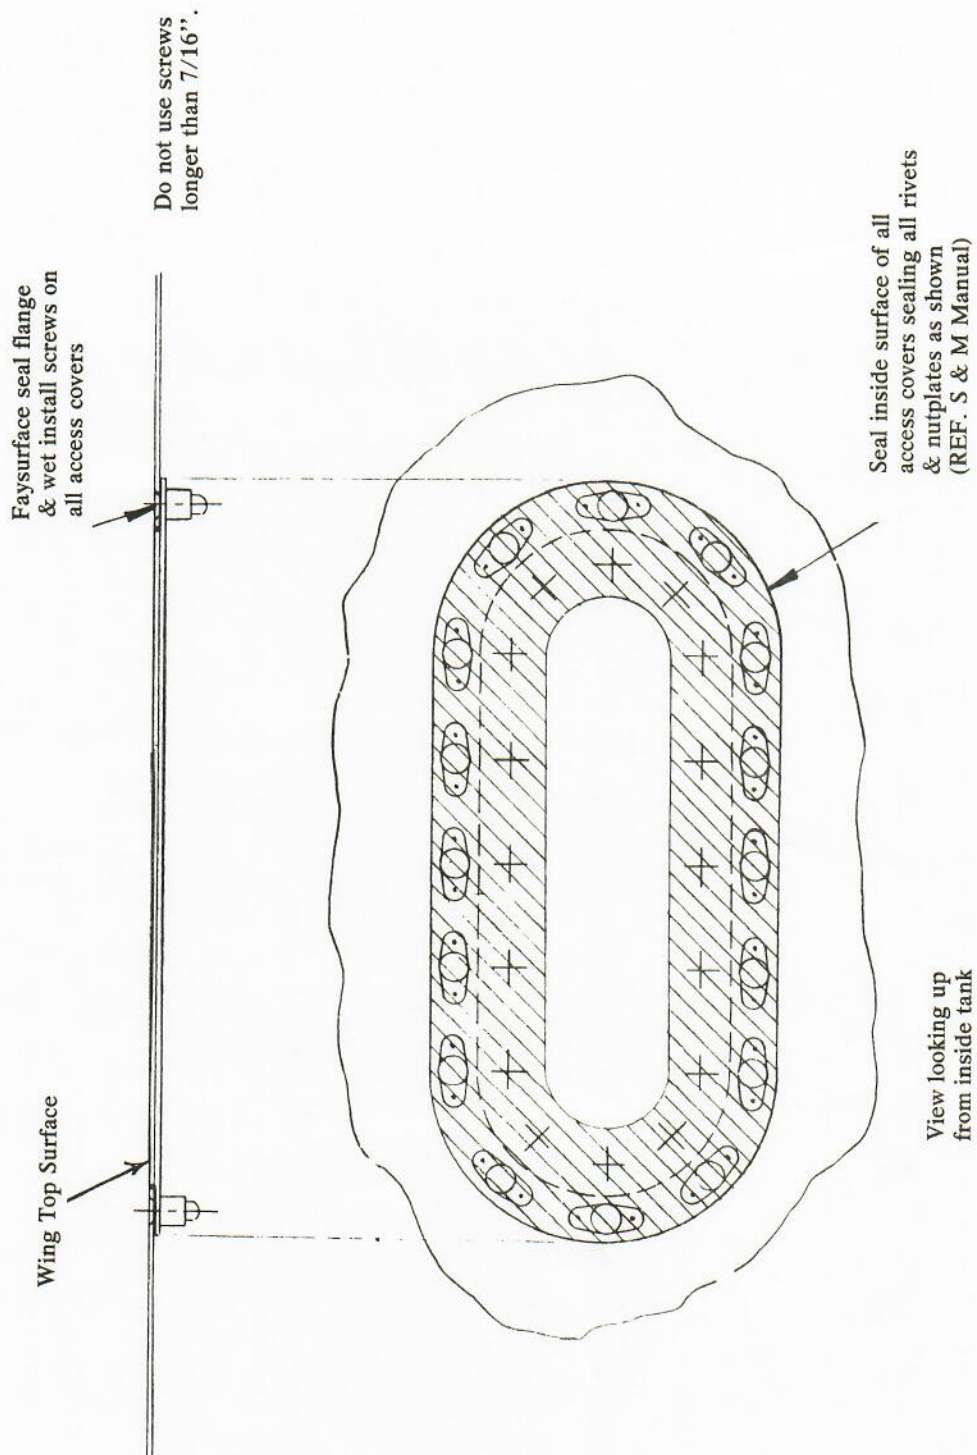
FIGURE M20-230-8

Use of AN507 screws longer than 7/16 inch will puncture acorn anchor nut in access plate.

8. Install all removed access covers per Service and Maintenance Manual and Figure M-20-230-8. Use PR1403-G-B2 or equivalent sealant as specified in S & M Manual, noting cure time. (PR1422B-1/2 or B-2 may be used if necessary)
