MOONEY AIRCRAFT INC.  
KERRVILLE, TEXAS

SERVICE LETTER 20-24

SERVICE BULLETIN M.20-24

SUBJECT: Kit-Improved replacement for P/N 7039 "Shaft assembly  
Nose Gear Steering Horn".

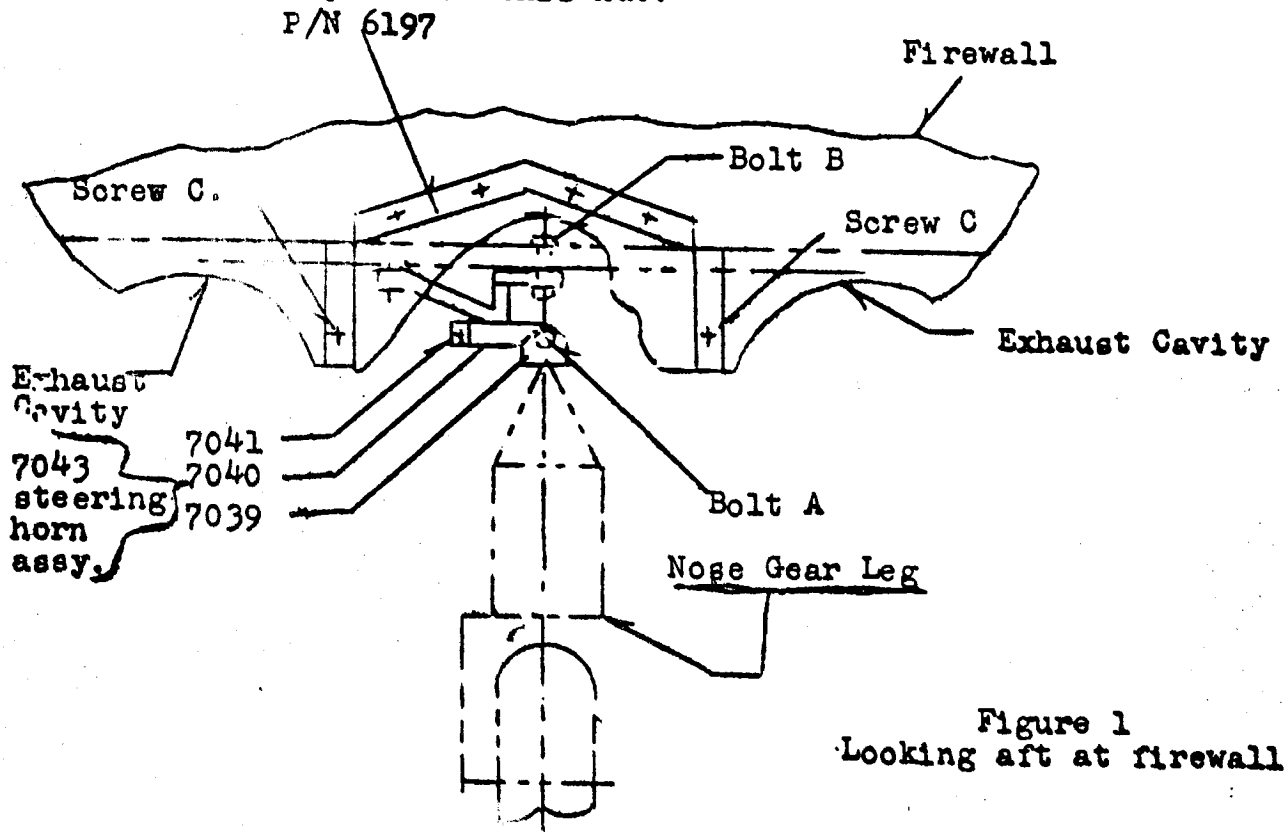
Figure 1  
Looking aft at firewall

There have been a few instances of failure of P/N 7039 (See figure 1) in which the long shaft separated from the tubular lug attaching it to the nose gear leg. A minor design change has strengthened this joint on the enclosed P/N 7039. To install this part follow the instructions below. (see figure 1).

1. Remove the side cowls.
2. Remove P/N 6197.
3. Remove bolt A and B.
4. P/N 7043 may then be removed from the airplane by detaching the Heim link at the rudder torque tube fittings. Do not change the adjustment of this link.
5. Remove P/N 7041 collar and P/N 7039.
6. Install new P/N 7039 and replace collar. Apply a light grease to the shaft. P/N 7039 should turn freely but should have a minimum of end play. The fit may be adjusted if necessary by filing P/N 7041 or using shims between it and P/N 7040.
7. Reinstall P/N 7043. At bolt A reinstall the hardened bushing from the old assembly, applying a light grease to its external surface. Bolt A should be pulled down tight. Screw C attaching P/N 6197 to the firewall has a loose speed nut behind the firewall access must be gained through partial removal of the exhaust cavities to position this nut.
