SUBJECT: MOONEY PFM, INSPECTION OF EXHAUST MUFFLER, MOONEY P/N 630024-001

MODEL/S/N
AFFECTED: MOONEY M20L, S/N 26-0001 THRU 26-0041

SERVICE BULLETIN M20-243

ISSUE DATE: 8 - 15 - 89

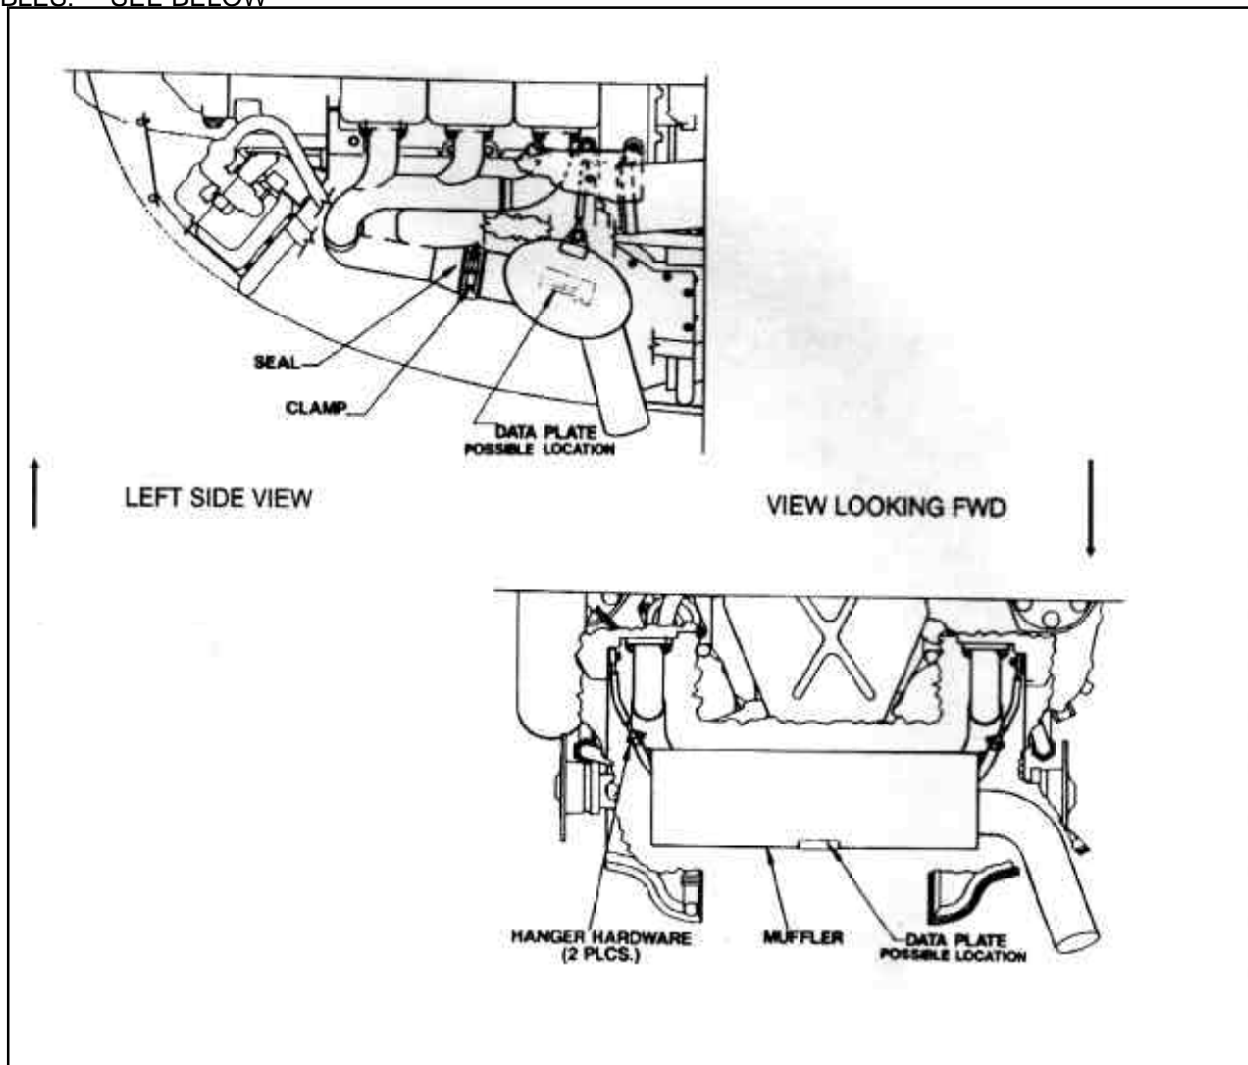
FIGURE M20-243-1

There is a possibility that certain early production units of the above listed muffler may develop exhaust leaks. This could lead to a condition which would allow exhaust fumes to enter the cabin. These mufflers can be identified by the presence of a welded-on data plate or excessive grinding in the area of the data plate on the muffler shell. Mufflers with the data engraved on the muffler shell and which do not have excessive grinding on the shell are not included in the production run of suspect mufflers and may be returned to service.

1. Remove both upper and lower cowling per M20L Service and Maintenance Manual (S & M) Section 71-10-00.
2. Visually inspect muffler assembly for presence of welded-on data plate (location can vary, ie. bottom of muffler shell, approximately C/L of engine case or on end cap opposite exhaust pipe end) (See Fig. M20-243-1), or for signs of excessive grinding near data plate area as well as other areas of muffler shell. If data plate is not on end cap, Step 3. will be necessary.
3. Remove 9 nuts, washers and bolts on cabin heat muffler shroud, P/N 630025-501, (front side only) to allow visual access to bottom of muffler. Retain the bolts, washers and nuts.
4. If welded-on data plate, signs of excessive grinding on muffler shell, or evidence of any exhaust leaks are present, the muffler **MUST BE REPLACED** with a new muffler which has the data etched on the shell.

The following must be accomplished [Steps, 4, (A) through (I)][Refer to M20L Parts Catalog, Figure 56, page 198]:

- A. Remove air ducts, inlet and outlet, for cabin heat muffler shroud.
- B. Remove and discard bolt, washer and nut (Index No. 3), clamp and seal (Index No. 2) that connects exhaust collector manifold to muffler.

- C. Remove two bolts and hardware, both sides, attaching muffler hanger brackets to hanger assemblies at Index No. 6 location.
 - D. Carefully lower muffler/shroud assembly clear of aircraft.

- E. Remove the aft row of bolts, washers and nuts from cabin heat muffler shroud and remove shroud from old muffler assembly. Retain all hardware.
 - F. Install shroud on new muffler assembly using existing hardware.

- G. Install new muffler/shroud assembly to the hanger assemblies (Index No. 5) at Index No. 6 location using existing hardware. Leave bolts/nuts loose until exhaust flanges are secured, Step H. below. Check studs that hold hanger assemblies to engine case for security. Use locktight on studs if loose.

- H. Use new clamp, seal and bolt, washer and nut to install new muffler to exhaust collector manifold. Use antiseize compound on bolt and nut. Torque muffler clamp bolt/nut to 200 In. lbs. Tighten hanger bracket's bolts and nuts.

- I. Reconnect cabin heat muffler shroud air ducts, inlet and outlet, using existing hardware.
5. If it is determined that the installed muffler is a good configuration unit, inspect entire muffler for signs of exhaust leaks, especially around welded seams and inlet and outlet pipes. This step will require complete removal of the cabin heat muffler shroud (See Steps 4., A. through E) unless the **OPTIONAL** method described below is used.
OPTIONAL - pressurize original good configuration muffler with 0.5 PSI air for leak check, if desired.

6. If there is no welded-on data plate, no sign of excessive grinding nor signs of any exhaust leaks, it is not necessary to replace the muffler and it may be returned to service. Etched data **MUST** appear on muffler shell.
