THIS SERVICE BULLETIN IS FAA APPROVED FOR ENGINEERING DESIGN

SUBJECT: MOONEY M20M, M20R, M20S, AIRFRAME INSPECTION

SERVICE BULLETIN M20-273
ISSUE DATE: 15 FEBRUARY, 2000
Revision C: 1 September, 2000
PAGE 6 of 7

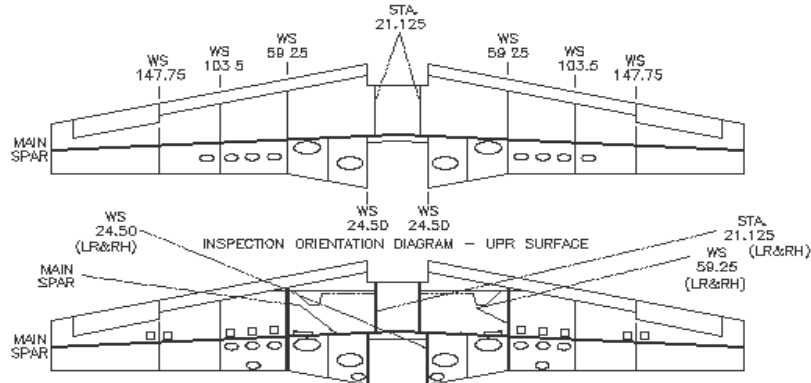
FIGURE SB M20-273-1.0

- INSPECTION ORIENTATION DIAGRAM - LWR SURFACE
- INSPECT STATION 21.125 AND STATION 29.25 RIB ASSYS. AND MAIN SPAR FROM INSIDE BOTH LH & RH LANDING GEAR WHEEL WELLS.
 - INSPECT STATION 24.50 RIB ASSY. FROM INSIDE CABIN.

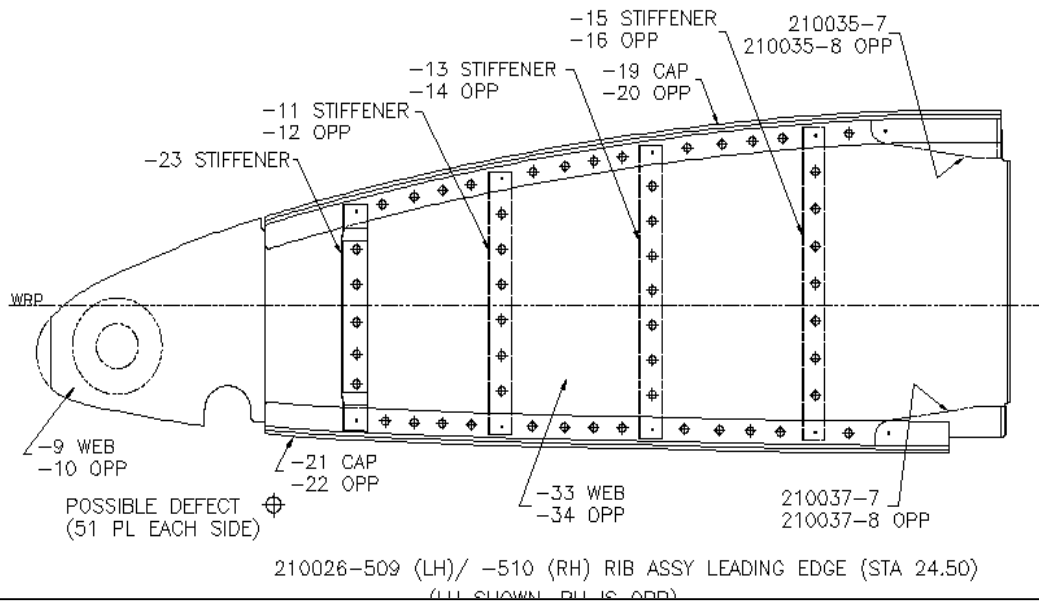
4. For inspection orientation, refer to Figure SB M20-273-1.0.
5. Inspect Wing leading edge Rib Assemblies, P/N's 210026-509 (LH)/-510 (RH), (Wing Sta. 24.50), from inside the cabin, for working, loose rivets or rivets seeping fuel per Figure SB M20-273-1.1.

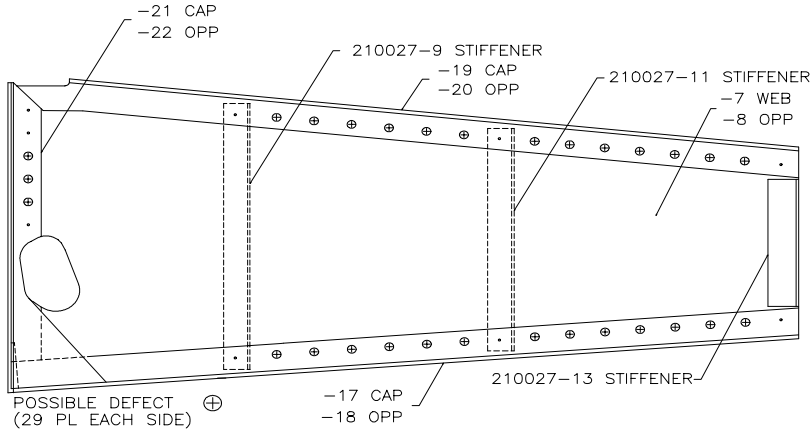
FIGURE SB M20-273-1.2

7. Inspect Wing Rib Assemblies, P/N's 210022-1 (LH)/-2 (RH), (Station 21.125), looking from inside LH & RH Main Landing Gear Wheel Wells for working or loose rivets per Figure SB M20-273-1.2.

210022-1 (LH)/ -2 (RH) RIB ASSY (@ STA. 21.125)
 (PLANNING No. 210408-901 (LH)/-902 (RH) RIB ASSYS [REF])
 (LH SHOWN, RH IS OPP)

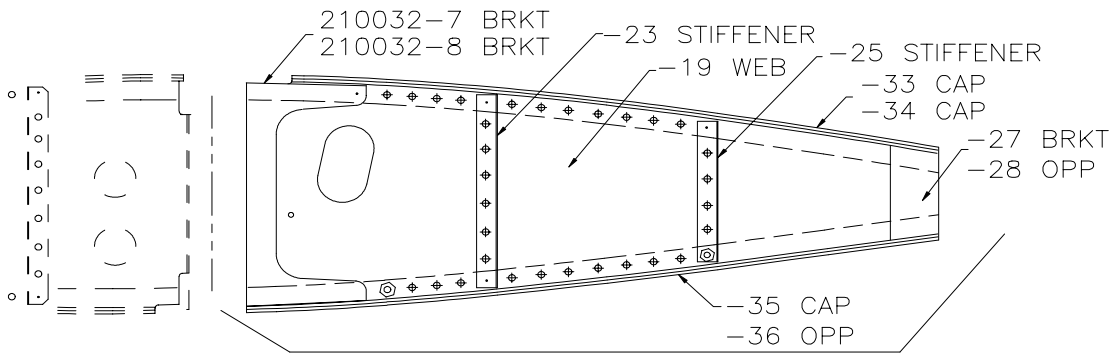
FIGURE SB M20-273-1.3

8. Inspect Wing Rib Assemblies, T/E only, P/N's 210022-3 (LH)/-4 (RH), (Wing Station 59.25), looking from inside LH & RH Main Landing Gear Wheel Wells for working or loose rivets per Figure SB M20-273-1.3.

210029-3 (LH)/-4 (RH) RIB ASSY, T/E ONLY, [@ STA. 59.250]
 (LH SHOWN, RH IS OPP)

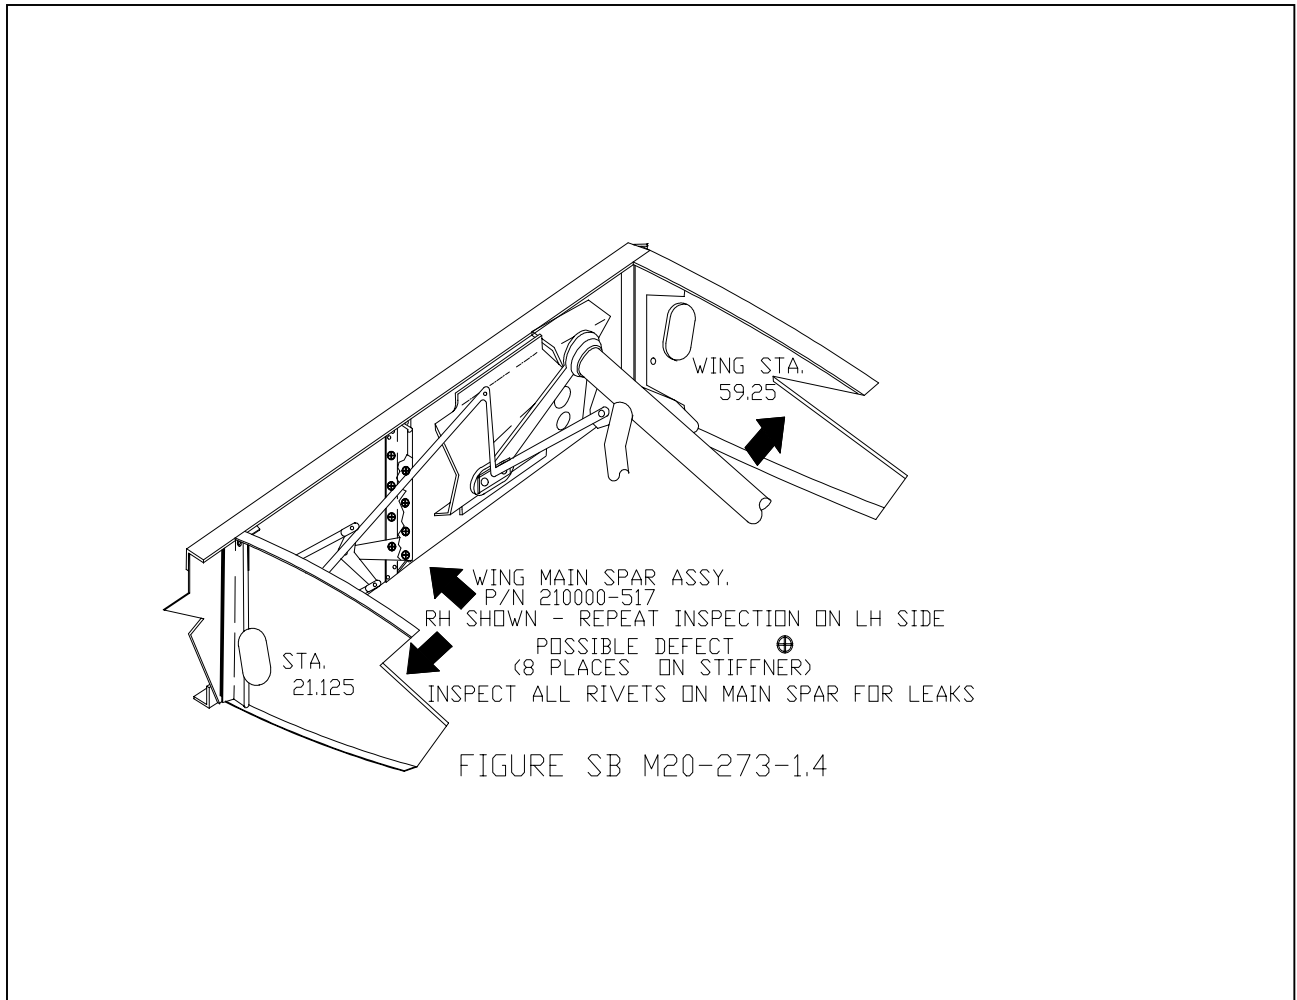
9. Inspect Main Spar Assembly Web Stiffeners, P/N's 210000-17 (LH)/-18, (RH), looking from inside LH & RH Main Landing Gear Wheel Wells for working or loose rivets and/or any rivets potentially seeping fuel per Figure SB M20-273-1.4.
10. If working, loose or leaking rivets are found, contact Mooney Customer Support immediately at (800) 331-3880 to schedule aircraft into Factory Service Center for repair.
11. Complete the enclosed Inspection Form with all requested information. Return this completed form to MAC Customer Support Department, Attn.: SB M20-273 Inspection Data, within 60 days of the date of this Service Bulletin.
12. Complete entry in Airframe Log Book stating compliance to MAC Service Bulletin M20-273. In addition, list the aircraft hourmeter time when next inspection is due per SB M20-273 TIME OF COMPLIANCE information. Refer to the following recommended logbook entry.
