SERVICE BULLETIN M20-281
Date: July 10, 2003

SUBJECT: Alternate Air Duct - Inspection for confirmation of configuration and subsequent replacement to new configuration.

MODELS/ S/N AFFECTED: M20M – S/N 27-0290 THRU 27-0316; and any S/N's, which may have had a Seamech original configuration alternate air duct installed as spare parts.

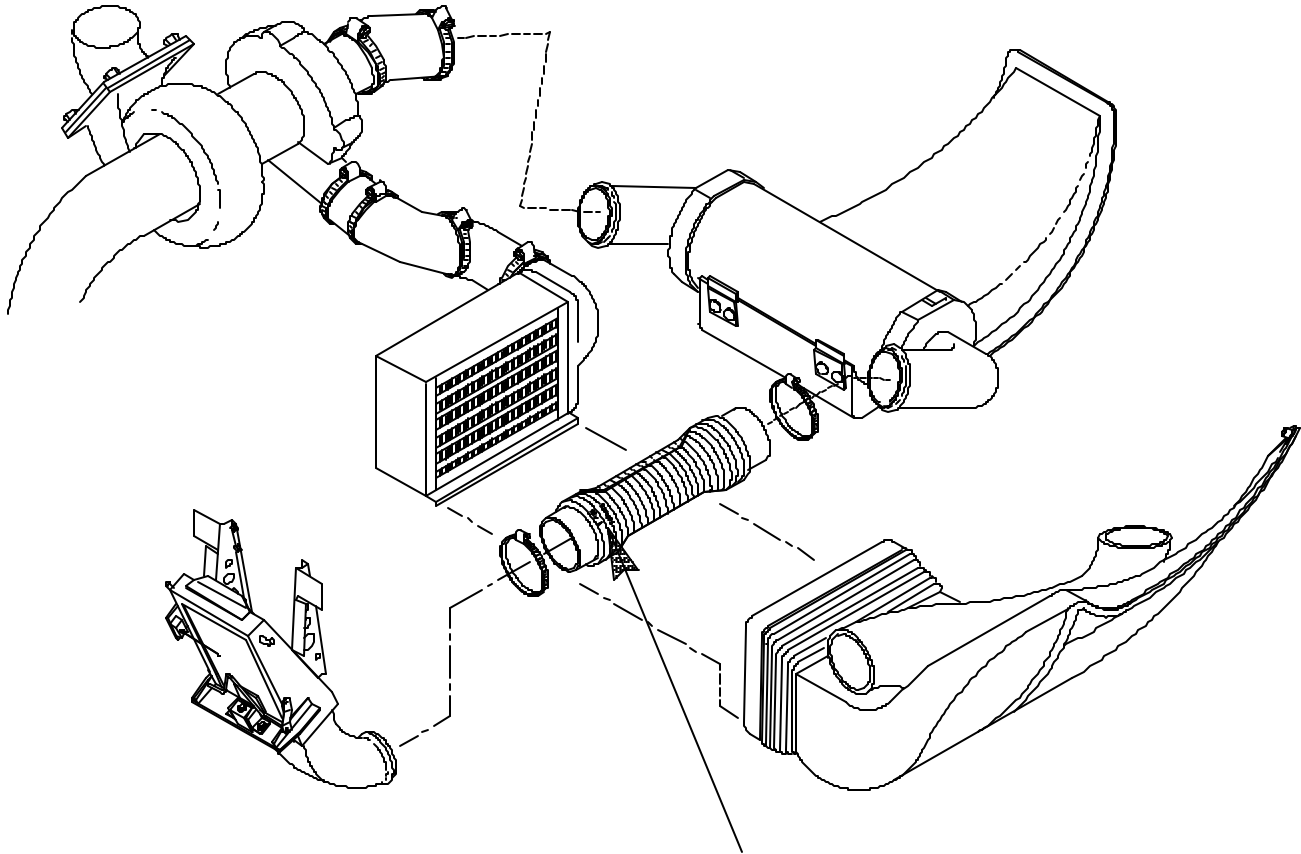
FIGURE SB M20-281-1

SEAMEGH P/N (& Rev. A) MARKED ON DUCT AT RANDOM LOCATIONS

1. Remove top and bottom cowling from aircraft.
2. Inspect the installed Alternate Air Duct for configuration identification. If the Seamech duct does not have (Rev. A) stamped/written adjacent to the P/N, the duct must be replaced.
3. Loosen hose clamps at both ends of the Alternate Air Duct, and remove the duct from the aircraft.
4. Replace with either a Baxter Woodhouse & Taylor, P/N X6913, or the Seamech, P/N 0906913 (Rev. A).
5. Install Duct and secure hose clamps at both ends.
6. Inspect entire engine compartment for obvious (visual) conditions of deteriorated or malfunctioning components.
7. Re-install bottom and top cowling onto aircraft.
8. Enter appropriate Log Book records to show compliance with SB-M20-281.
9. Return aircraft to service.
