SERVICE BULLETIN M20-292A

Date: December 22, 2006

SUBJECT: ENGINE MOUNT INSTALLATION AT FIREWALL

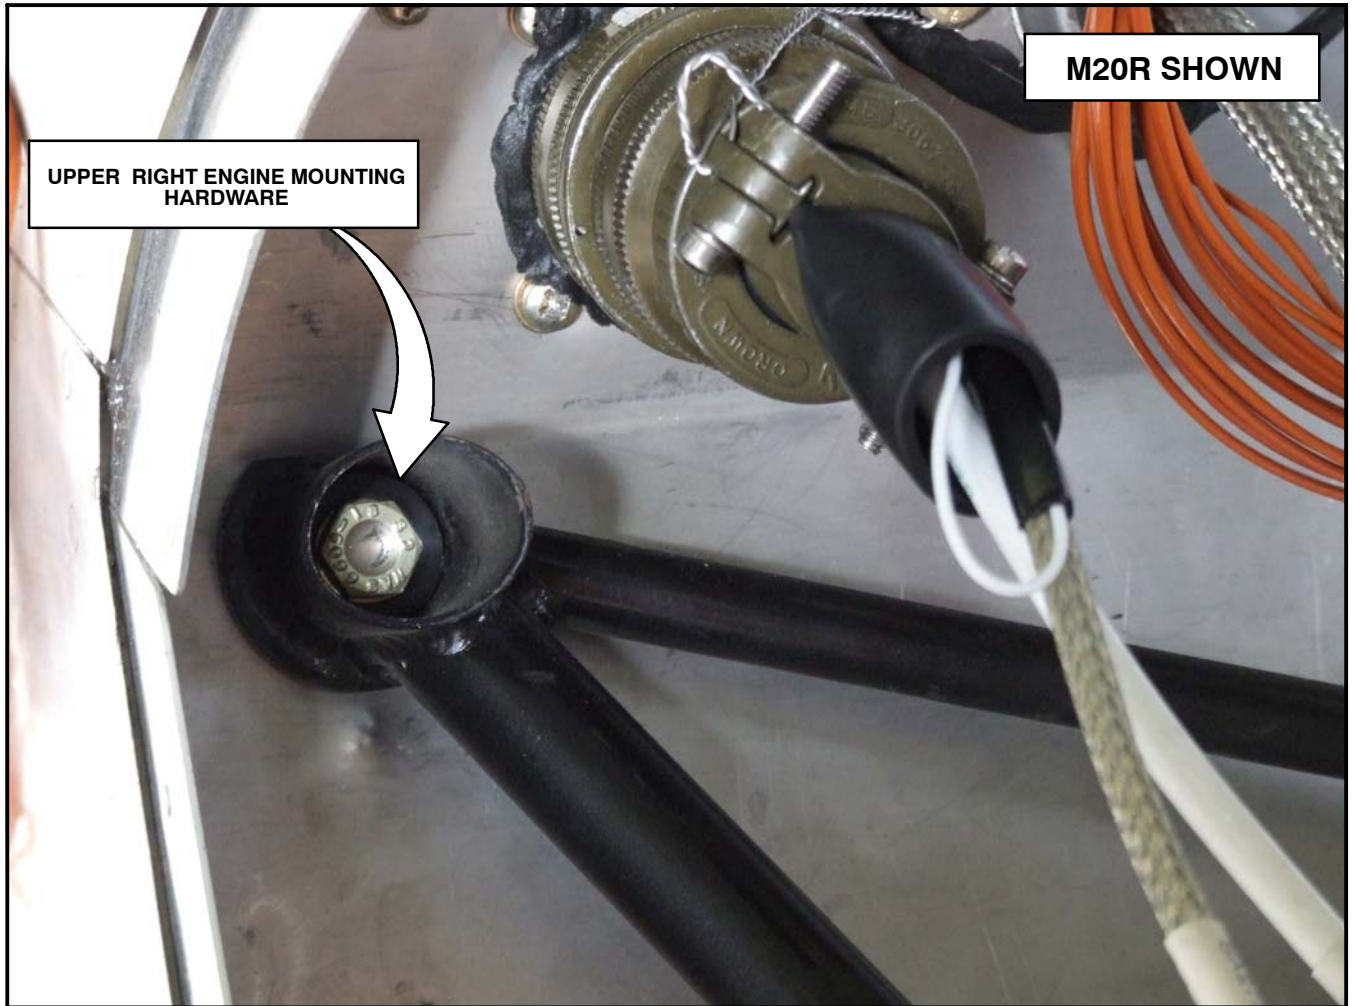
Figure SB M20-292-1

It has been determined that the firewall insulation and upholstery covering attached to the interior surface of the firewall, located behind the instrument panel, may be compressed between the fuselage tubular frame and the stainless steel firewall at the upper left and upper right engine mount points. This may prevent the engine mount attaching hardware from maintaining torque to engineering design. The upholstery and insulation material must be trimmed from around the engine mount attaching points on the interior surface of the firewall and the fuselage tubular frame, to allow metal to metal contact of these components. The engine mount attaching hardware must be replaced and retorqued to engineering design tolerances at the upper left and upper right engine mount locations.

1. Turn master switch - OFF.
2. Remove upper cowling.
3. Locate and retorque upper left and upper right engine mounting hardware (ref. Figures M20-292-1 & M20-292-2):
