SUBJECT: M20TN ENGINE ISOLATOR MOUNT INSPECTION

MODELS/ SN M20TN - 31-0002 thru 31-0023 and 31-0025 thru 31-0127
AFFECTED:

TIME OF COMPLIANCE: **INITIAL INSPECTION WITHIN 10 FLIGHT HOURS / NEXT 100 HR INSPECTION**

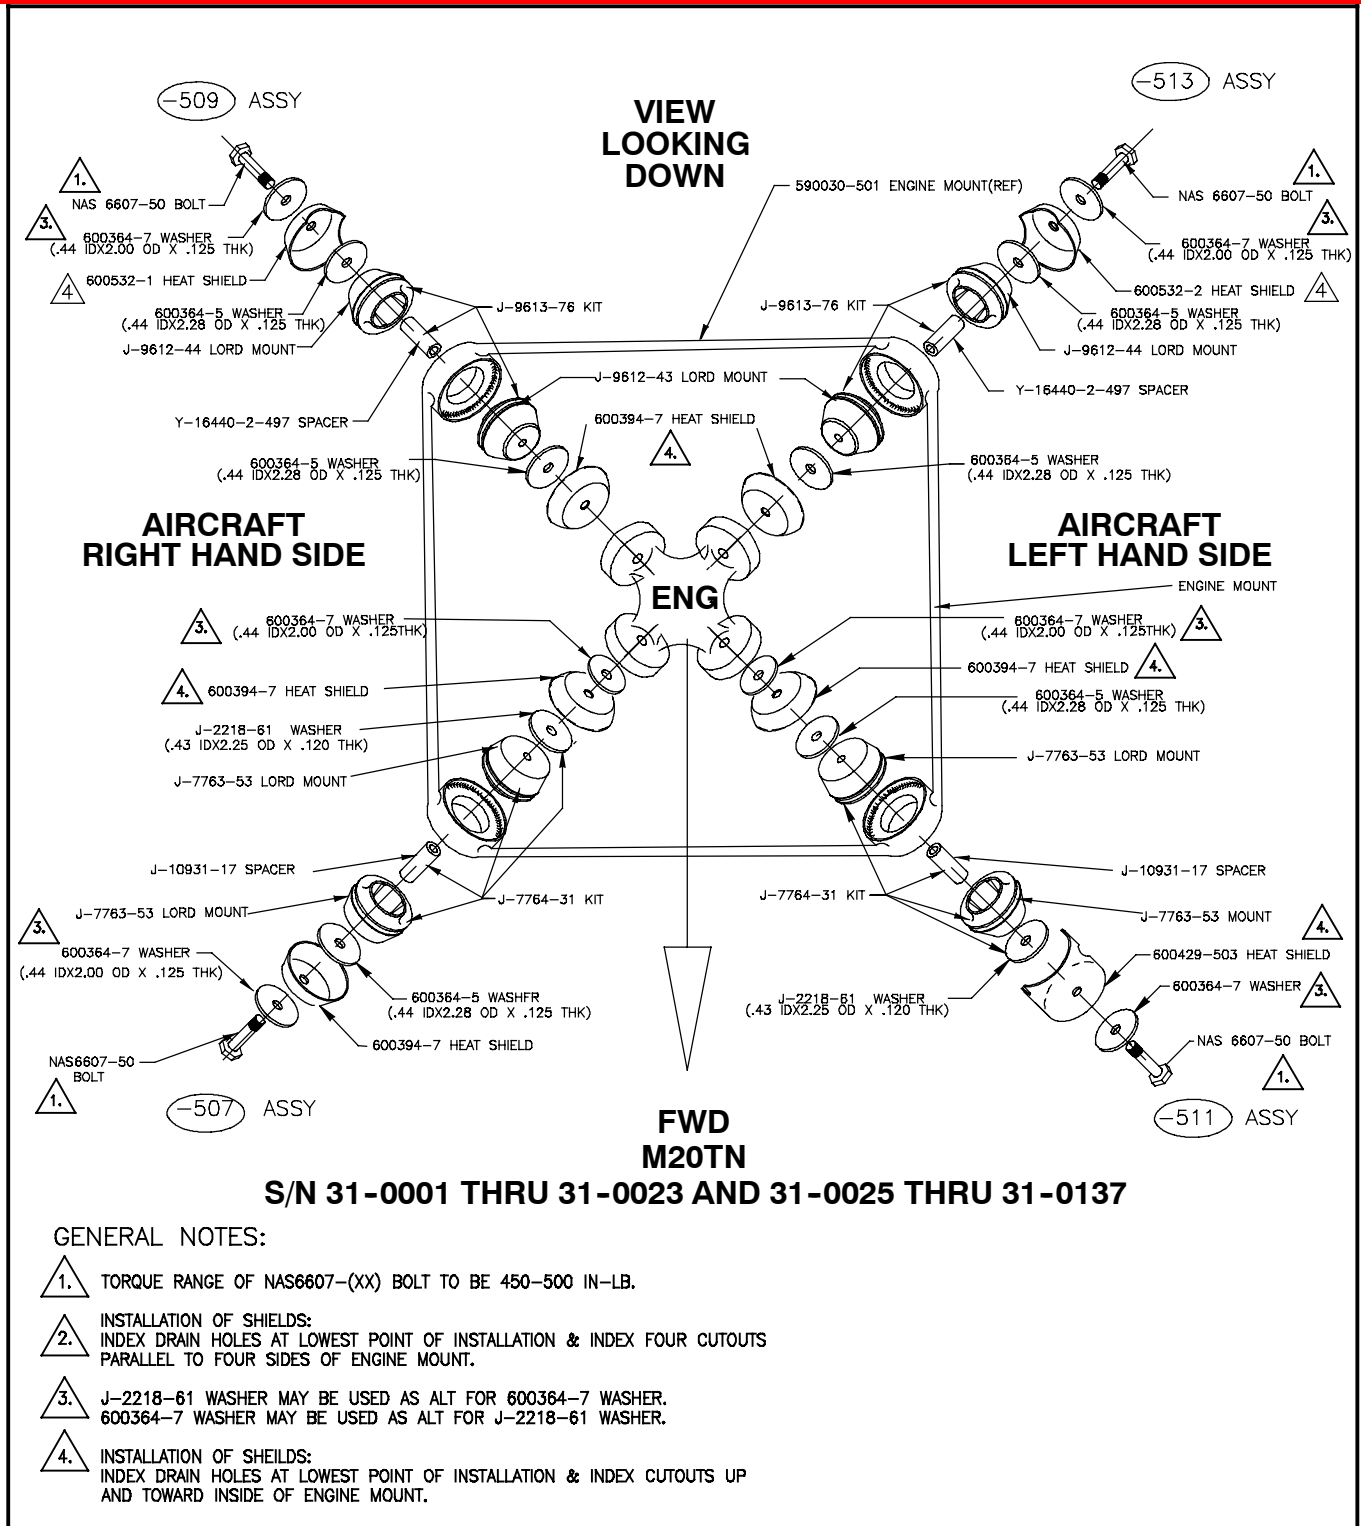
Figure SB M20-316-1 - ENGINE MOUNT AND HARDWARE INSTALLATION

INTRODUCTION: There has been a report from the field of improper clamp-up and distortion of the mount isolators, as well as extreme difficulty in the re-installation in general. Both the service manual and illustrated parts catalog incorrectly identified the mounting sequence (refer to Mooney Service Instruction M20-121) and will be updated at their next revision cycle to reflect this information. Because the exact history of this installation is unknown, an inspection is required for field M20TN's to verify engine installation.

The arrangement of engine isolator mounts is extremely critical. Make certain they are arranged as shown in Figure SB M20-316-1.

- 1.10. If movement has been determined, continue to next steps of this service bulletin.
- 1.11. Refer to **STEP 2** and remove each isolator (one at a time), verify correct and/or stack-up as shown in Figure SB M20-316-1 (Refer to MAC Service Instruction M20-121).

- 2.13. Correctly position each heat shield in place per figure 1, index drain holes at lowest point of installation & index cutouts parallel to sides of engine mount. Make sure heat shields are oriented to prevent chaffing or interference on engine mount or engine components.
- 2.14. Install both retaining bolts, washers and torque to specification - refer to Figure SB M20-316-1.
- 2.15. Reinstall top and bottom cowling, refer to MAC Service and Maintenance Manual.
- 2.16. Complete log book entry.

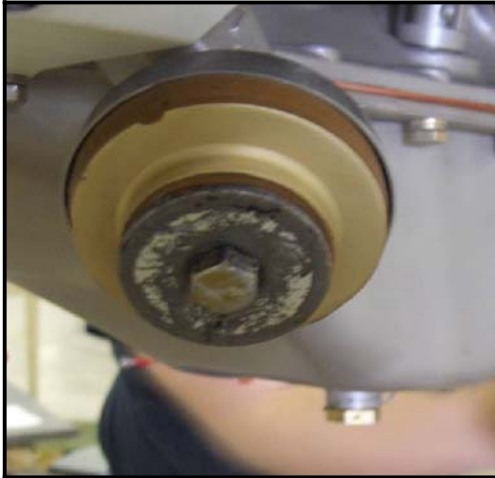
TIGHTEN "DUMMY" BOLTS (NAS6607-15 OR EQUIVALENT) TO COMPRESS RUBBER MOUNTS

- 2.8. Use "dummy" bolts (NAS6607-15 or equivalent) and washers to secure each of the upper halves of isolator mounts. Ensure upper washer and heat shield are installed between isolator and engine motor mount castings (4 places). Tighten bolts to compress rubber mounts to approximate thickness shown in Figure SB M20-316-2.

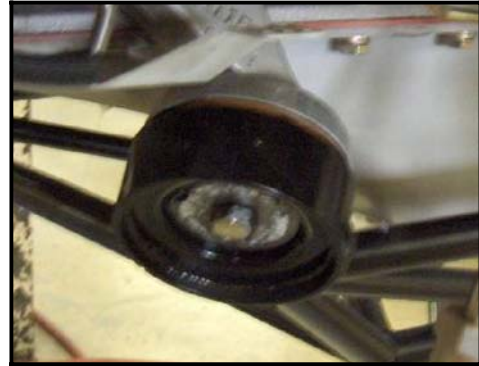
**ISOLATOR MOUNT SEATED
REMOVE - "DUMMY" BOLTS**

- 2.12. Once top engine mounts are all seated in the cups, begin removing "dummy" bolts and washers. Start at right rear (RR), then left rear (LR), left front (LF), and right front (RF).

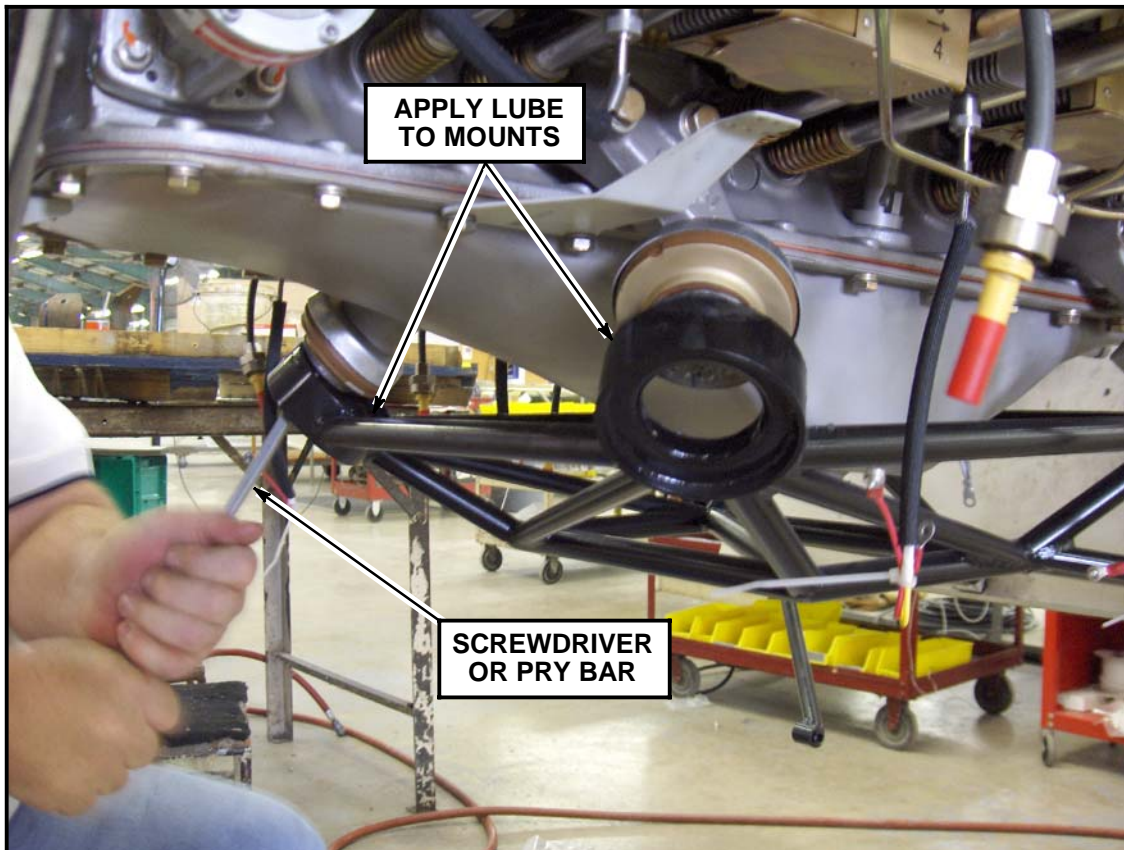
Figure SB M20-316-2 - INSTALL ENGINE ISOLATOR MOUNTS AND HARDWARE

- 2.9. Before lowering engine, lube all four mount cups with silicone lubricant to help facilitate alignment.
- 2.10. Slowly lower engine into motor mount cradle. Support weight of engine with lift until engine is properly placed in mount. When engine is first lowered, the isolator mounts will not rest squarely in the cups on the mount refer to Figure 2. Seat both rear mounts first, then front left & right mounts.

- 2.11. Use a large flat screwdriver to pry mounts into cups. This step requires a considerable amount of patience and "elbow grease" - refer to Figure SB M20-316-2.
