SUBJECT: Service Instruction M20-88A - STABILIZER TRIM STOP/SCREW MODIFICATION  
Dated 12/14/2016.

SERVICE INSTRUCTION M20-88A  
Date: December 14, 2016

SUBJECT: STABILIZER TRIM STOP/SCREW MODIFICATION

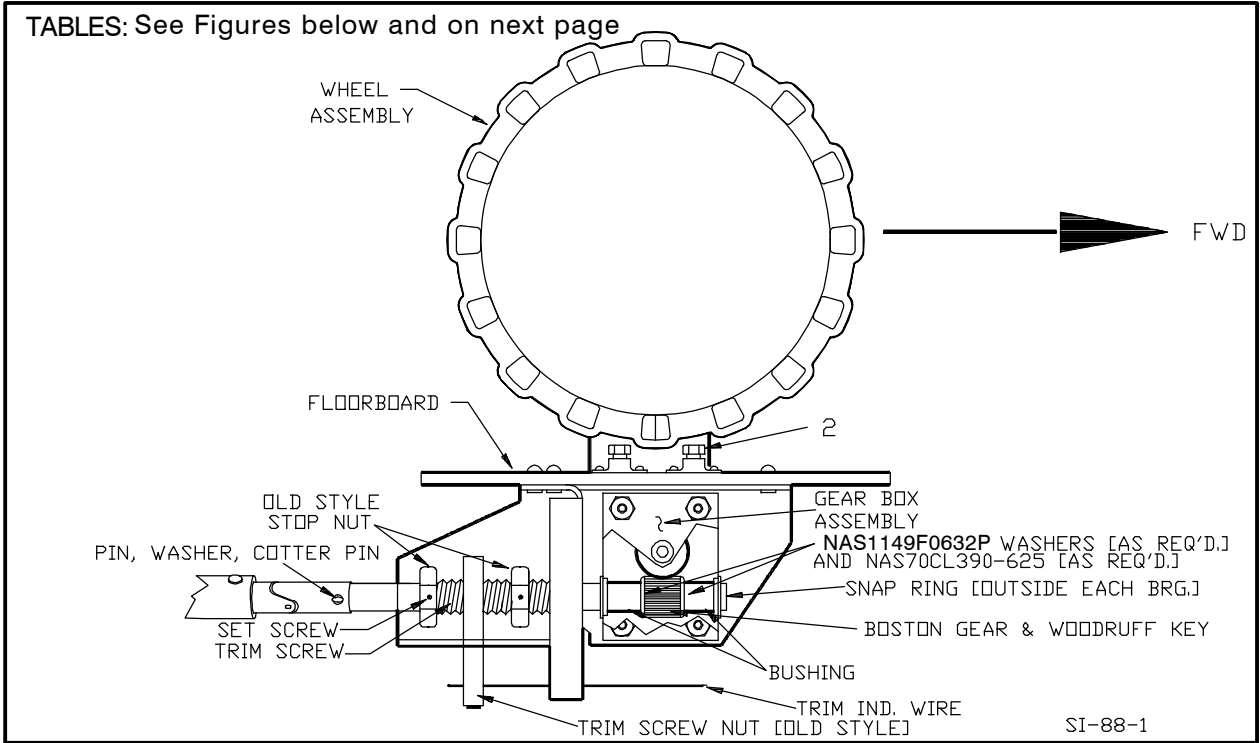
**Figure SI M20-88-1**

There have been occasions when the elevator trim control wheel has been manually turned to the extreme nose up or nose down condition and the electric trim system was unable to move the trim indicator nut off the stop at the next electrically activated command. Manual movement must be the initial action to get the trim indicator nut off the stop, then the electrical system will operate normally.

4. Remove cotter pin, washer and pin that secures trim tube universal joint to trim screw (Figure SI M20-88-1).
5. Loosen gear box bolts (Index 1, Figure SI M20-88-2) if not already done, and both NAS428-3-4 bolts (Index 2, Figure SI M20-88-2) to give slack in roller chain between upper and lower sprocket of trim control wheel assembly.

7. Remove roll pin, P/N RPA52-028-125-1125 holding lower sprocket, P/N 740049, to gear box shaft. Remove sprocket.
8. Loosen set screw, #6-32 x 1/8, in each existing trim stop so they will unscrew easily. Remove aft trim stop (DN stop) from trim screw (Fig. SI M20-88-1).

12. Measure and document longitudinal free play in trim screw shaft (end play) as assembled in the gear box assembly.
13. Remove forward snap ring from trim screw. Reference Figure SI M20-88-1
14. Lightly tap trim screw at forward end, with a plastic mallet, to drive trim screw, bushings, washers, gear and aft bearing from gear box assembly housing. Bearings are installed with loctite (Blue) at assembly, so some effort may be required to break it loose. **DO NOT DAMAGE BEARING OR HEATING THE HOUSING.**
15. When existing trim screw, and components attached to it, comes free from gear box housing, the bushings, washers, gears, woodruff key, snap ring and aft bearing will be removed. Retain components, except woodruff key, to place back on new trim screw (Fig. SI M20-88-1).
