SERVICE BULLETIN M20-34

SUBJECT: Inspection - Main Landing Gear Shock Absorber Unit
MODELS AFFECTED: M20 & M20A All Airplanes
TIME OF COMPLIANCE: Immediately and at Subsequent Periodic 100 Hour Inspections

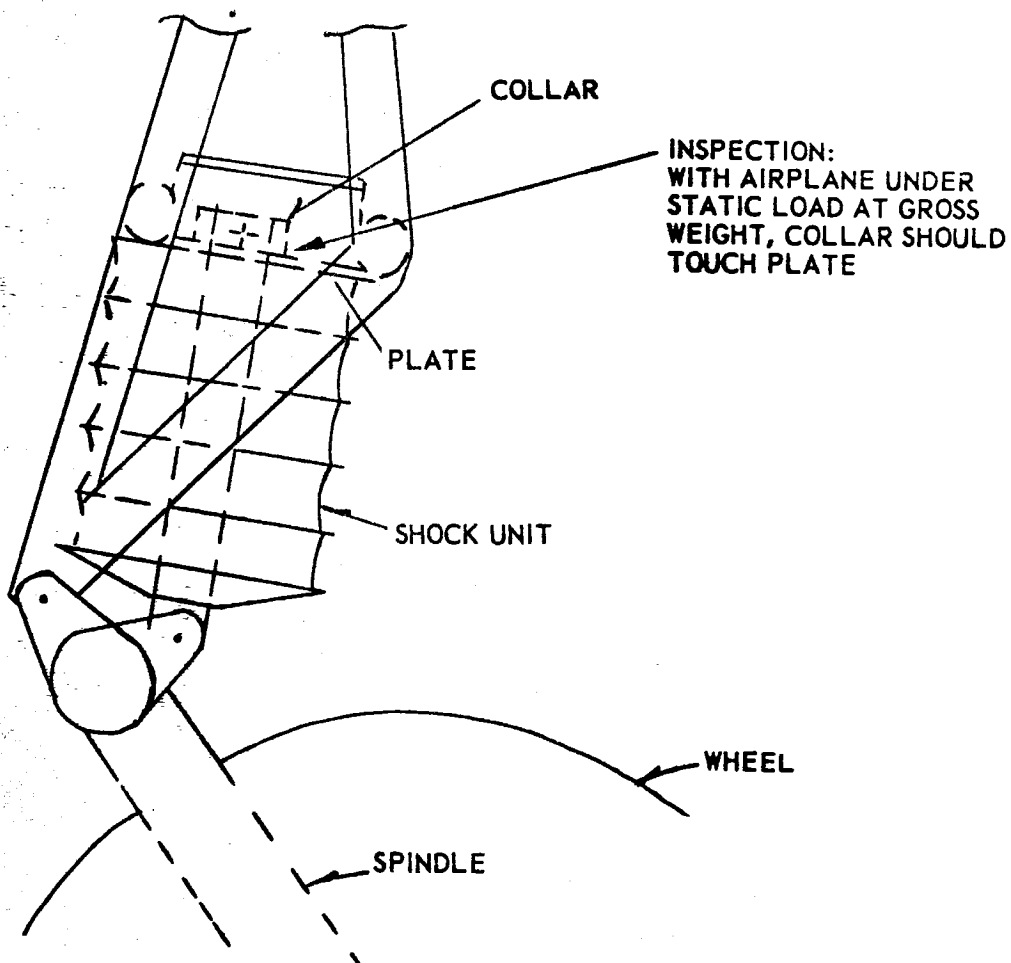
A failure of the main gear shock absorber unit has occurred on one M20 airplane in which the shock unit failed to extend the spindle and wheel after the take off ground run and caused the out of position wheel to hang in the wheel well after retraction. The stack of rubber discs are pre-loaded and should be strong enough to fully extend the spindle and wheel under static load at gross weight. It is therefore necessary to accomplish the inspection described in the sketch below on the main landing gear. If the shock unit fails to pass inspection the rubber discs must be replaced. Please accompany any orders with airplane serial number and time on gear.
