SUBJECT: Oil Cooler Air Deflector
MODELS AFFECTED: M20-A, Serials 1201 thru 1700
 M20-B, Serials 1701 thru 1856

This Service Letter reidentified as
 Service Bulletin M 20-83
 per Service Instruction M20-15.

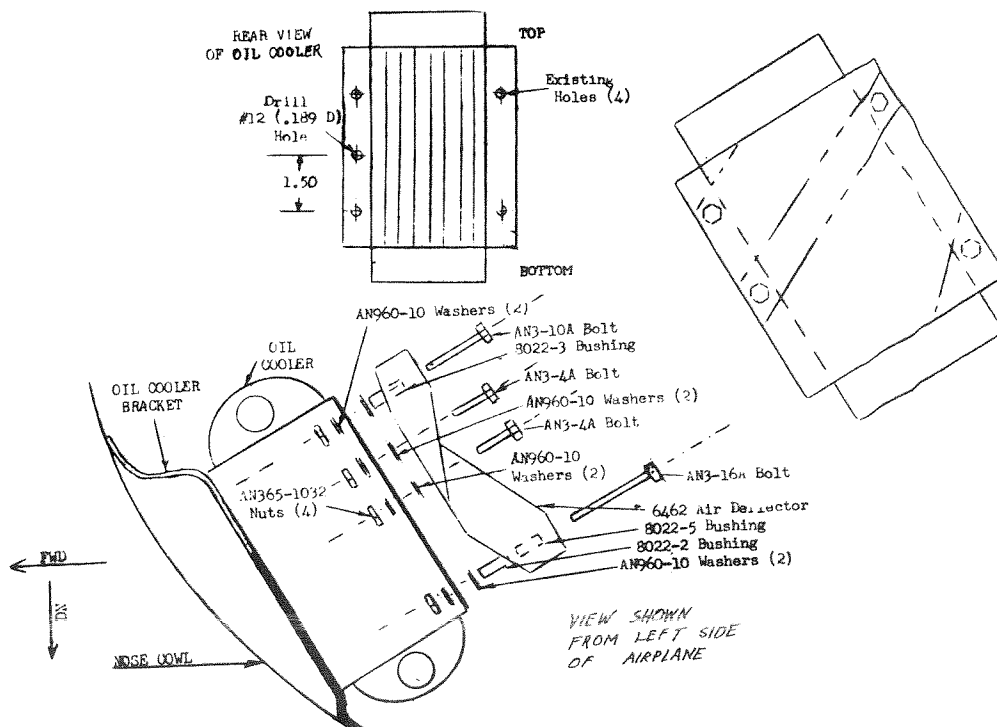
There have been some instances where the left front exhaust stack has cracked in the vicinity of the oil cooler air outlet. It is possible that a deflector, placed on the oil cooler outlet, would deflect cold air and moisture so it would not come in contact with the hot exhaust stack, thereby eliminating possible failures in this area.

It will be necessary to remove the left side cowl in order to take the oil cooler off. Completely remove the oil cooler by taking off four attach bolts and two oil hoses. Drill extra hole in oil cooler flange as called out in attached rework and installation diagram. Reinstall oil cooler in reverse order of removal.
