SUBJECT: Main Landing Gear Wheel Well Rework
MODELS AFFECTED: M20, M20A, Serial Numbers 1002 thru 1645
TIME OF COMPLIANCE: Next 100 Hour Inspection or not later than May 15, 1962

This Service Letter reidentified as
Service Bulletin M 20-89
per Service Instruction M20-15.

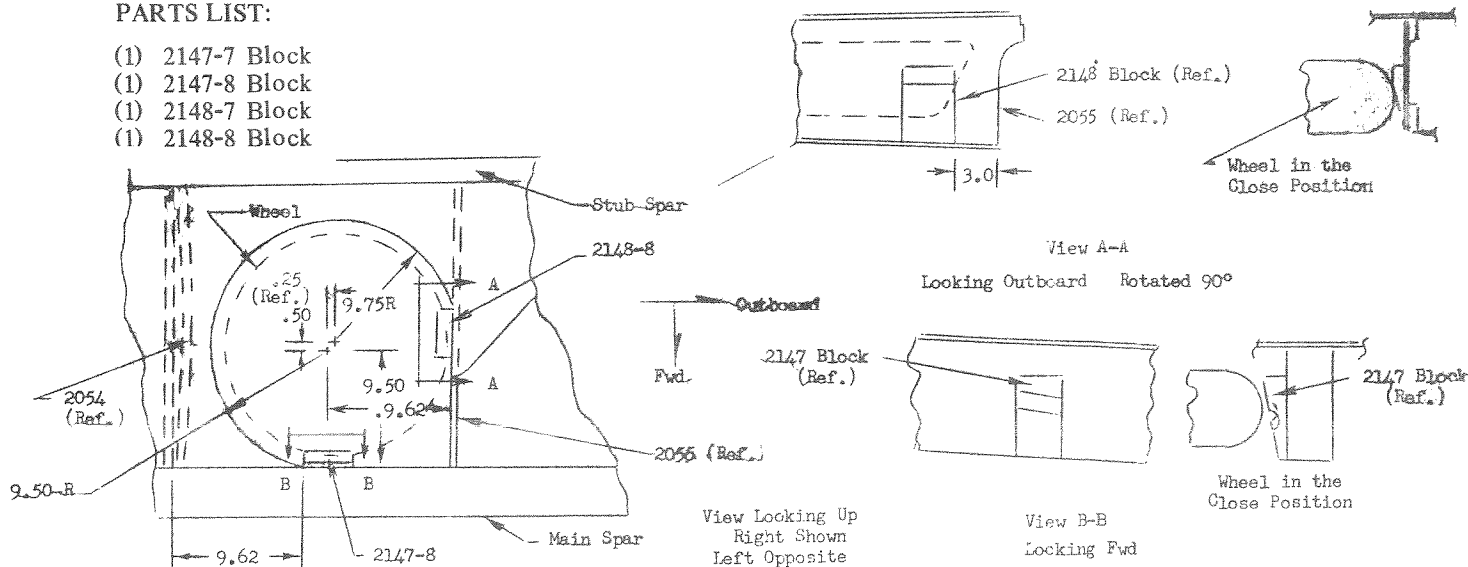
Additional cases of unwanted gear retraction during the past year have disclosed the fact that the main gear tire sometimes drags on the skin at the edge of the wheel well cutout. This results in undue effort being required to lower the gear and can, in extreme cases, cause warpage or failure of retraction linkage parts. This Service Letter is necessary to prevent further occurrences.

Mooney Service Letter 20-59 gave instructions for increasing the dimensions of the wheel well cutouts. The dimensions specified in the sketch below should be used rather than the ones stated in Service Letter 20-59. In addition to the cutout increase, it is necessary to add the blocks shown in the sketch. These blocks will prevent the tire from hanging should the shock discs, retainer collar, or bolt fail.

In installing the wood blocks, a medium file should be used to remove the dope and varnish from the spar and rib. Use Borden's Cascophen RS-216 (or RS-224) or Weldwood to glue the blocks and clamp for twenty-four hours at 70° F.

Interior surfaces in the wheel well area should be given two coats of spar varnish followed by a coat of aluminized sealer mixed in the following proportions: sixteen ounces of aluminum paste or one half pound of aluminum powder to each gallon of spar varnish.

The cutout area must be recovered with fabric tape, doped with butyrate dope, and repainted with matching dope color.
