SERVICE INSTRUCTION M20-104
ISSUE DATE: 15 SEPTEMBER, 1997

SUBJECT: Landing/Taxi Light bulb rotation to re-orientate filament from horizontal to vertical.

MODELS/S/N

AFFECTED: M20J - S/N 24-3154 thru 24-3412
M20K - S/N 25-1225 thru 25-2013
M20L - S/N 26-0001 thru 26-0041
M20M - S/N 27-0001 thru 27-0240
M20R - S/N 29-0001 thru 29-0129

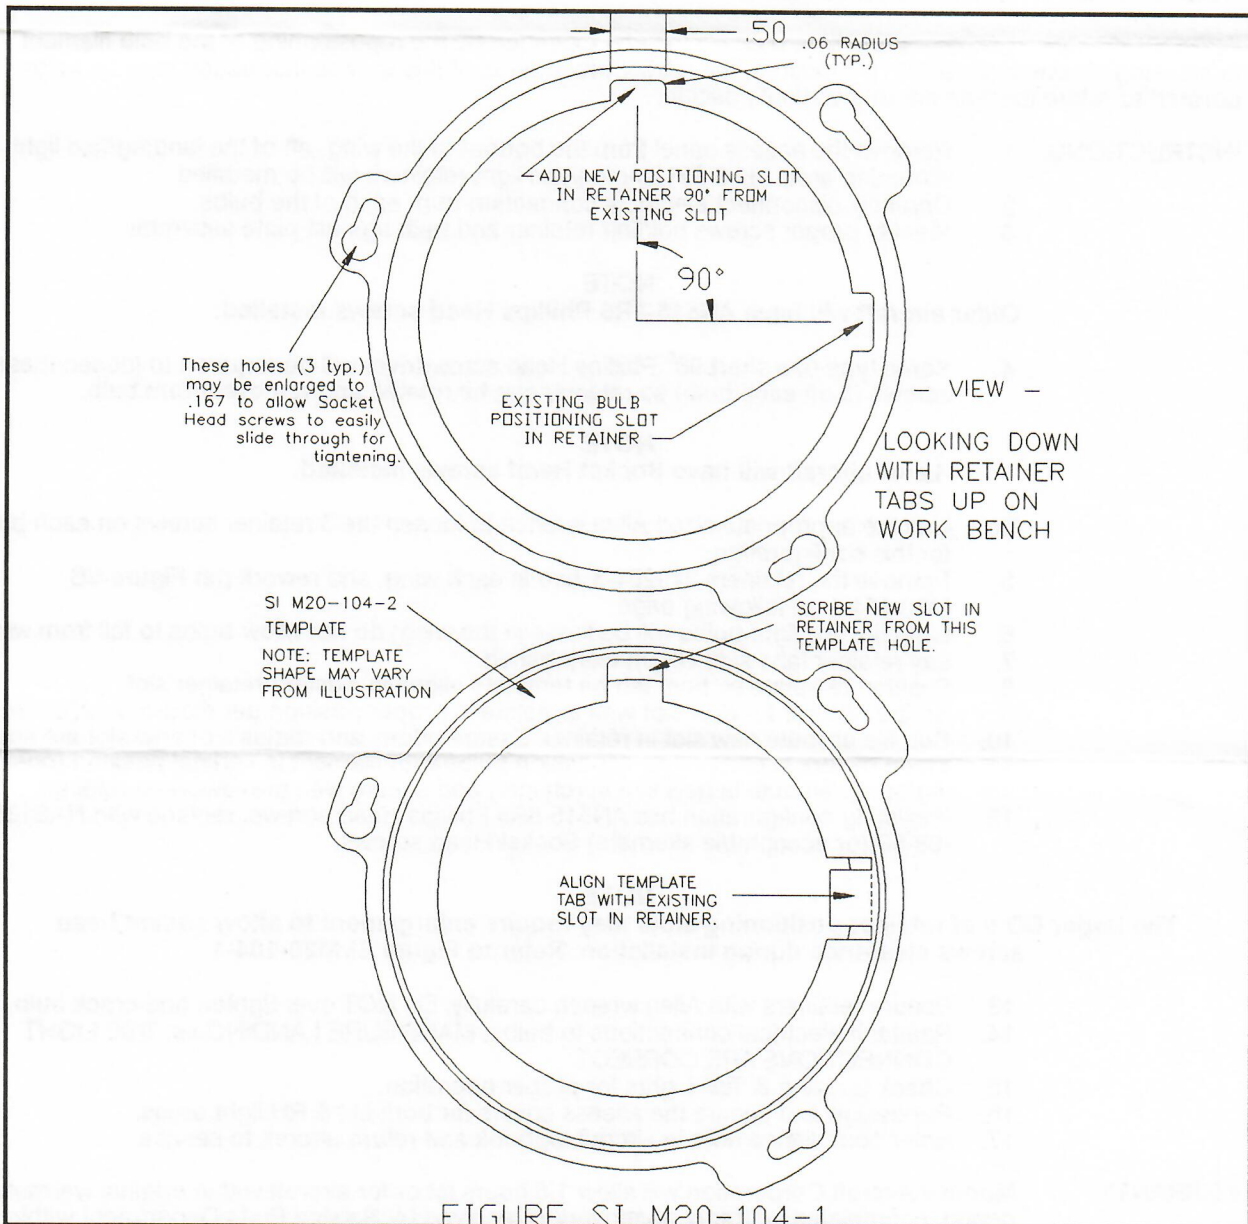
FIGURES/TABLES: See Figure SI M20-104-1 below:

INTRODUCTION: Landing & taxi light bulb life may be extended by the repositioning of the bulb filament in the wing mounted installation. If desired, the retrofit procedures of this service instruction may be incorporated to rotate the filament to a vertical position.

- 4a. Use the appropriate sized Allen wrench to loosen the 3 retainer screws on each bulb for this configuration.
5. Remove the retainers, 210204-3, two in each wing, and rework per Figure SB M20-104-1 on following page.

9. Scribe retainer for new slot with template in proper position per Figure SI M20-104-1.
10. Cut, file or route new slot in retainer. Ensure edges and radius's of new slot are smooth.

The larger OD's of retainer positioning slots may require enlargement to allow socket head screws clearance during installation. Refer to Figure SI M20-104-1
