SERVICE INSTRUCTION M20-105

DATE: 21 APRIL, 2000

SUBJECT: ENGINE MOUNT INSPECTION/REPAIR, COWL FLAP MODIFICATION

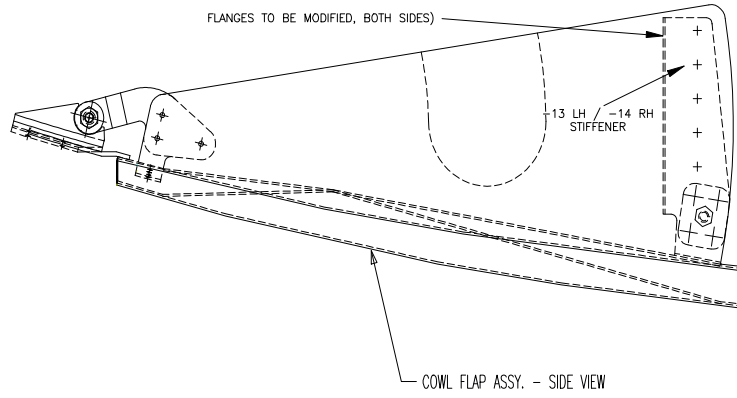
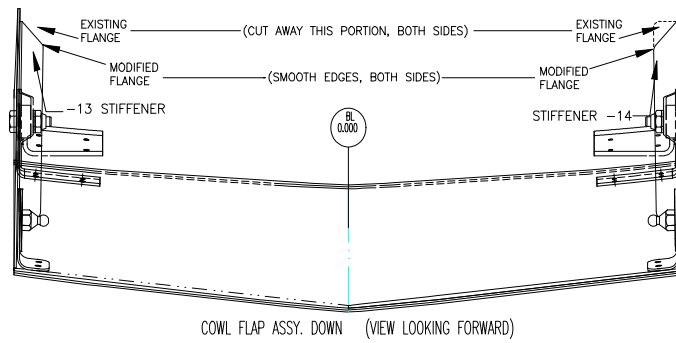
FIGURE SI M20-105-1

COWL FLAP MODIFICATION

INTRODUCTION: Some M20K (Encore) models have exhibited contact between the cowl flap stiffener plate and lower engine mount tubes, LH & RH sides, while the aircraft is in flight. The interference/contact is not normally present in static conditions. As the aircraft's speed increases, the cooling ram air pressure coming through the cowling inlet openings and exiting through the cowl flap area, creates sufficient pressure to slightly distort the cowl flap and cause the stiffener plate's angled flange to contact the lower engine mount tubes. Over a period of time, the aluminum plate flange will abrade the steel, engine mount tubes. This area requires inspection, and repairs, if necessary.

7. Disconnect cowl flap from linkage mechanism on both sides of cowl flap. Let cowl flap hang down for access.
8. Mark a 45° angle on the upper, top, tip end of the stiffener angled flanges, both sides of the cowl flap, from the flange bend radius area to the outside edge of the flange.
See Figure SI M20-105-1.
9. Carefully cut this marked portion from the stiffener flange of each stiffener on the cowl flap assembly.
10. Burnish the cut edges, especially in the flange's bend radius area. Radius the outer edge of the flanges with a file to approximately a 1/8 inch outside radius.
