SERVICE INSTRUCTION M20-110

**SUBJECT:** TO ADVISE OWNERS OF AMSAFE SERVICE LETTER 23-003 (ATTACHED).

# SERVICE LETTER 23-003

**Subject:** Manufacturing Condition Notification for 90-degree Inflator Assemblies, P/Ns 508795-401 (ROI-V2, 3.1 Mole, Internal Filter) and 508794-401 (ROI-V2, 2.3 Mole, Internal Filter).

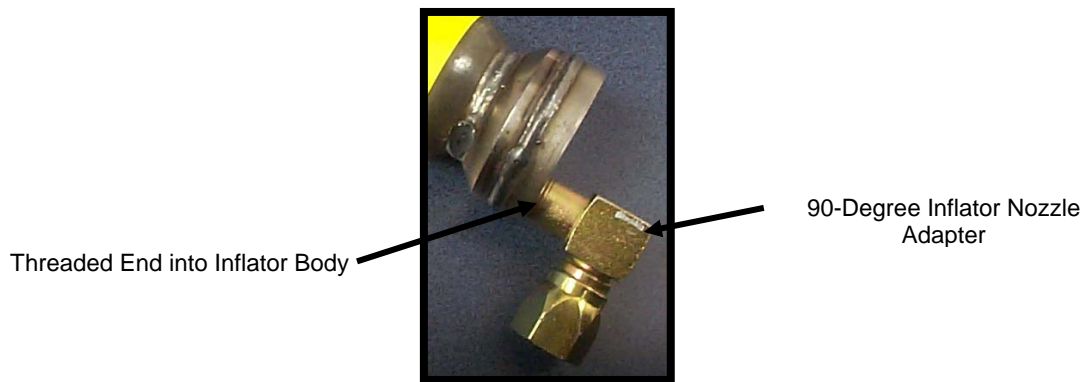
**Figure 1 – 90-degree Inflator Nozzle Adapter**

It has been brought to AmSafe's attention that these Inflator Assemblies may have been shipped for installation onto aircraft with less than optimal torque applied to the 90-degree Inflator Nozzle Adapter that seats into a threaded connection on the Inflator body (see Figure 1). This manufacturing condition may result in manual manipulation of this 90-degree Inflator Nozzle Adapter.

AmSafe Engineering has determined that this manual manipulation of the nozzle adaptor condition does not affect AAIR System performance, personal safety, or inflator storage concerns. Existing in-service, properly-installed 90-degree Inflator Assemblies are not susceptible to further degradation of this fitting's minimum engagement threshold and immediate corrective action is unnecessary.

AmSafe recommends that all 90-degree Inflator Assemblies be inspected (as directed below) as soon as practical by the procuring aircraft OEM/service center for this manufacturing condition. If a 90-degree Inflator Assembly is found to have this condition, return the affected inflator back to AmSafe Aviation. Upon receipt of the affected inflator, AmSafe will replace the 90-degree Inflator Assembly free from this manufacturing condition.

Attempt to manually rotate (either direction) the 90-degree Inflator Nozzle Adapter within its threaded connection. If this can be accomplished without any tools, then Inflator Assembly should be replaced.
