SUBJECT: TO ADVISE MOONEY M20J OWNERS OF CORRECT MOUNTING SEQUENCE OF THE PROPELLER GOVERNOR SPACER PLATE AND GASKETS WHEN PROPELLER GOVERNOR IS REMOVED.

MODELS/ SN AFFECTED: All Mooney M20J Aircraft with Dual Magneto Engines with Rear Mounted Propeller Governor Drives.

SERVICE INSTRUCTION M20-120

Date: August 30, 2012

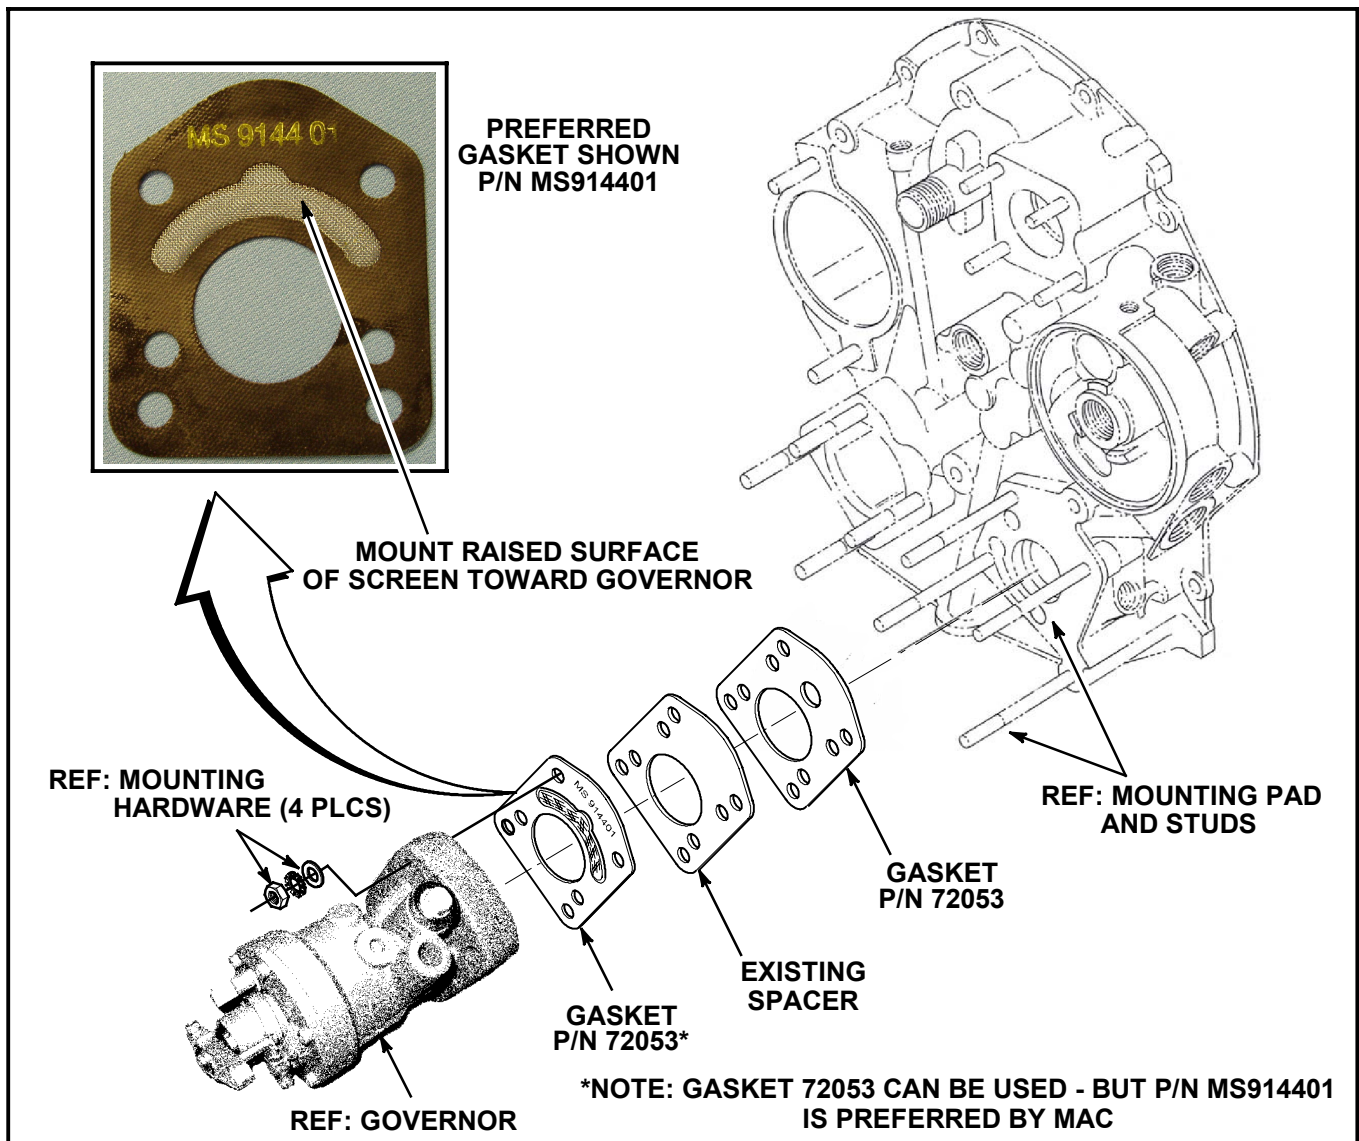
Figure 1 - REAR MOUNTED GOVERNOR PLATE AND GASKET INSTALLATION

INTRODUCTION: There has been a report in the field, of in flight engine failures (several airframe MFG's) resulting from the incorrectly installed gaskets/spacer plate stack-up on "Lycoming four and six cylinder, dual magneto engines with rear mounted propeller governor drives". The M20J MAC Service and Maintenance Manual, Chapter 61, paragraph 61-20-10, identifies "new gasket" and not "new gaskets" as well as the mounting sequence. This SI M20-120 amplifies the removal and installation information, and will be incorporated in the next manual revision cycle.

FAILURE TO INSTALL CORRECT PART NUMBER AND/OR QUANTITY OF GASKETS AND SPACER PLATE IN PROPER SEQUENCE COULD RESULT IN SIGNIFICANT OIL LEAKAGE, ENGINE DAMAGE AND POSSIBLE IN FLIGHT ENGINE FAILURE.

- 1.9. Install new gasket (p/n 72053) onto studs and block mounting pad as shown in Figure 1.
- 1.10. Install existing spacer plate onto studs and new gasket (p/n 72053)

- 1.11. Install new gasket (p/n MS914401) with raised screen surface toward governor onto studs and existing spacer plate as shown in Figure 1.
- 1.12. Position governor on mounting studs, aligning the governor splines and the splines of the accessory drive, making sure governor surface is flush against mounting pad.
