SUBJECT: OPERATION OF OVERWEIGHT AIRCRAFT

MODELS/ SN M20K - ALL

SERVICE INSTRUCTION SIM20-132

Date: August 30, 2018

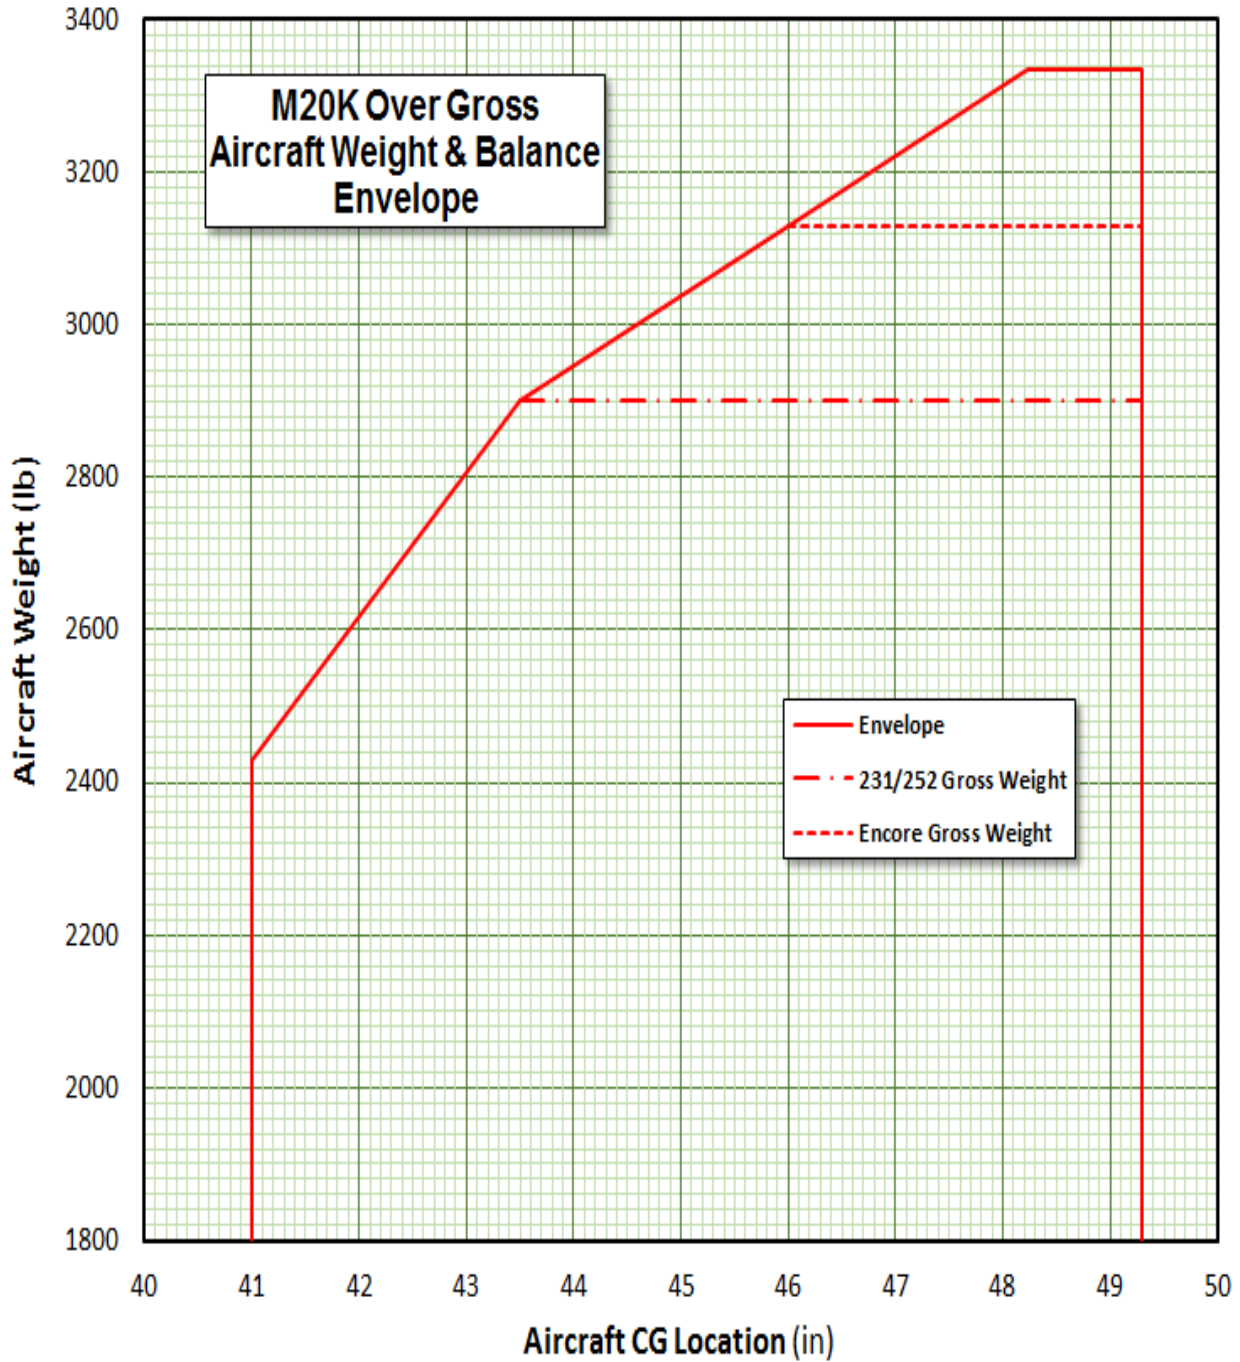
FIGURE SIM20-132-1 - STRUCTURES CENTER OF GRAVITY ENVELOPE

- 1.1. The existing center of gravity envelope at and below 2900 pounds (231/252) and 3130 (Encore) remains unchanged. The structural weight and balance envelope will be expanded as shown in **Figure SIM20-132-1**.
