SUBJECT: OPERATION OF OVERWEIGHT AIRCRAFT

MODELS/ SN M20M - ALL  
AFFECTED: M20R - ALL  
M20S - ALL  
M20TN - ALL  
M20U - ALL  
M20V - ALL

TIME OF COMPLIANCE: AS REQUIRED

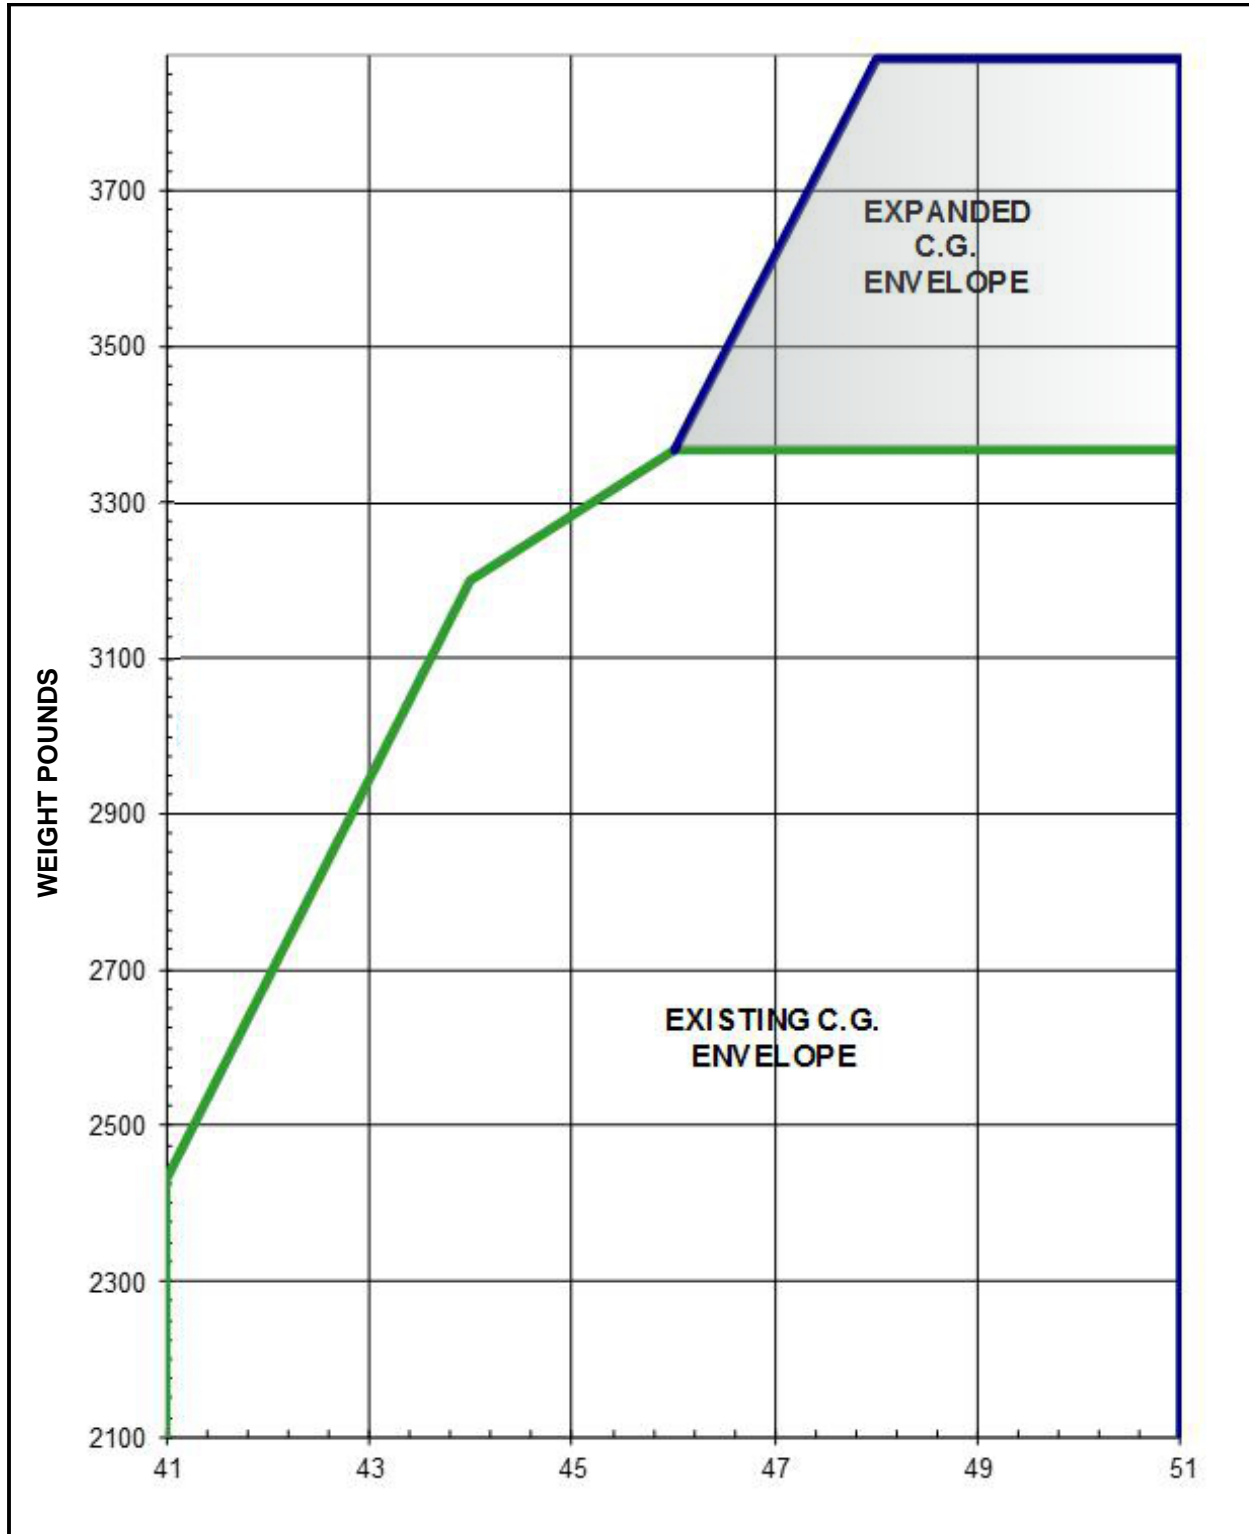
FIGURE SIM20-133-1 - STRUCTURES CENTER OF GRAVITY ENVELOPE

- 1.1. The existing center of gravity envelope at and below 3368 pounds remains unchanged. The structural weight and balance envelope will be expanded as shown in *Figure SIM20-133-1*.

115% OVER WEIGHT C.G. POINTS		
POINT	C.G (IN.)	WEIGHT (LB)
OVER WT. FWD.	48.0	3870
OVER WT. AFT.	51.0	3870
