NUMBER: S.I. M20-65

DATE: 2-24-83

SUBJECT: SYMBOLIC DISPLAYS INC., (S.D.I.) FT-101 FUEL FLOW MEASURING SYSTEM, MOONEY M20J and M20K

MODELS/S/N AFFECTED: Mooney Model M20K, S/N 25-0001 & ON, M20J, S/N 24-0001 & ON with FT-101 system installed.

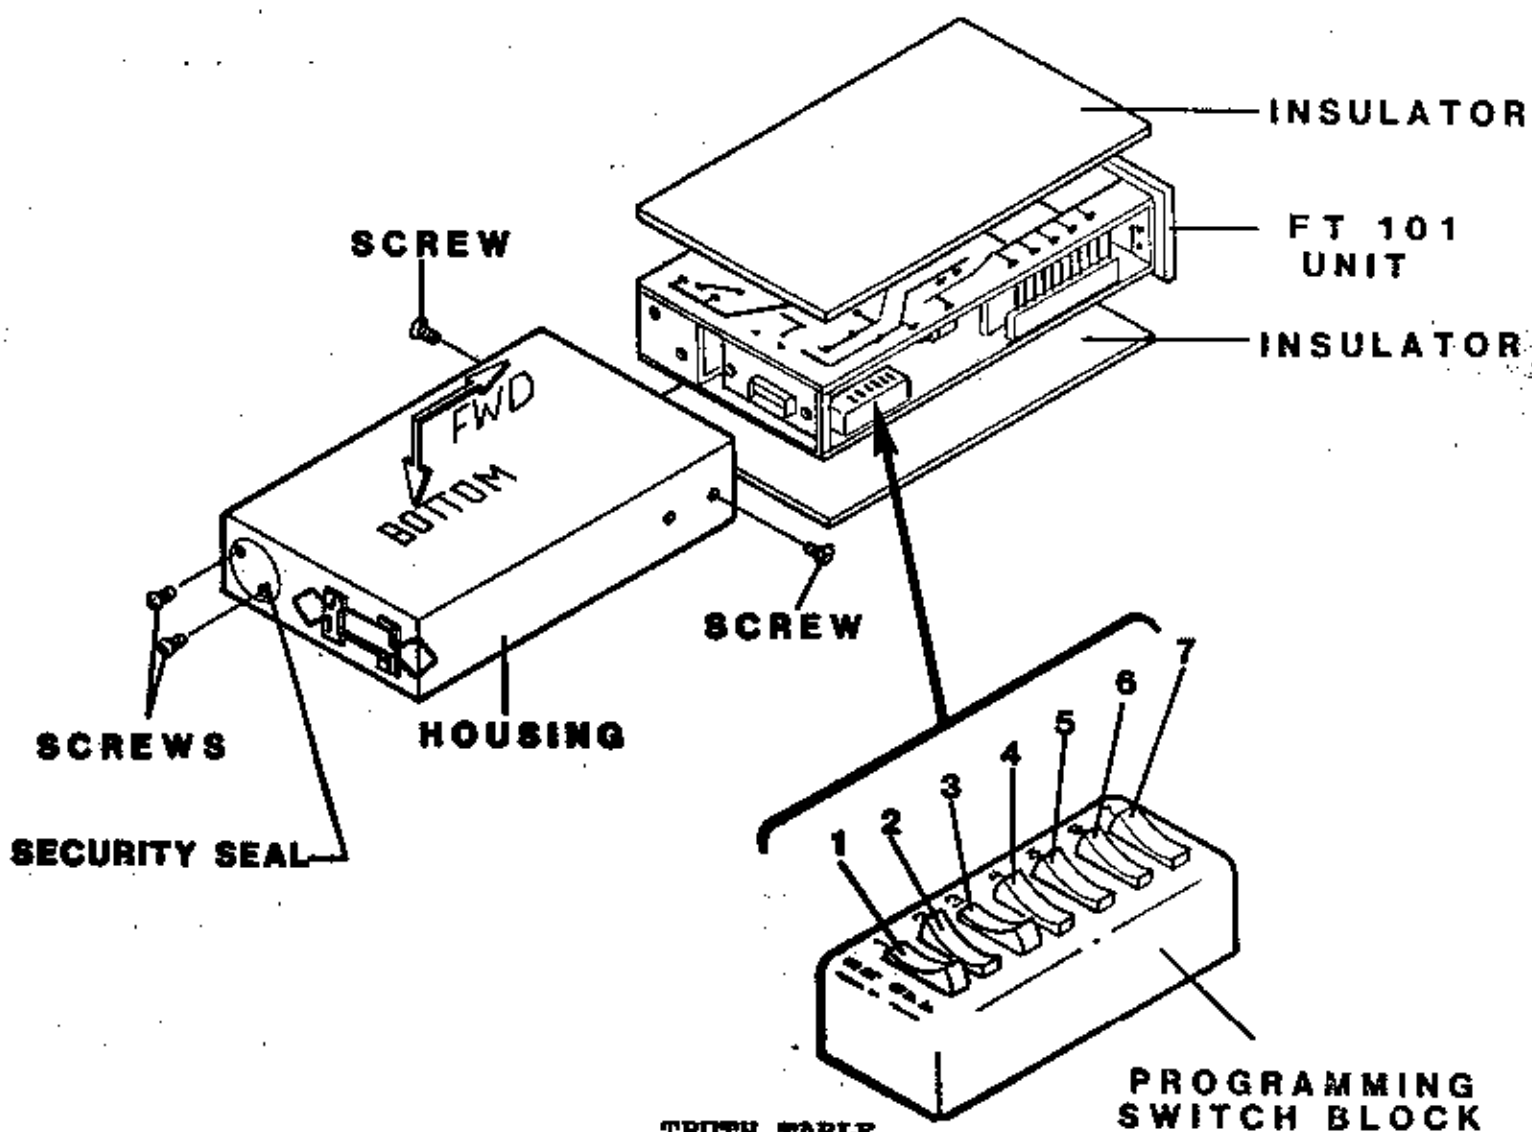
TRANSDUCERS ARE CATEGORIZED BY THE NUMBER OF PULSES PER SECOND OUTPUT FOR A GIVEN GPH FLOW RATE ("K FACTOR"). THIS WILL BE NOTED AS: L, M, H, OR HH SCRIBED ON THE END OF THE SERIAL NO. FOR ACCURATE READINGS, THE FT-101 INTERNAL SWITCHES MUST BE MATCHED TO THE TRANSDUCER. SEE TRUTH TABLE ABOVE.
