SUBJECT: Engine isolator, mount attach bolt, location of washer under bolt head.

MODELS/S/N AFFECTED: M20M - S/N 27-0001 THRU 27-0137

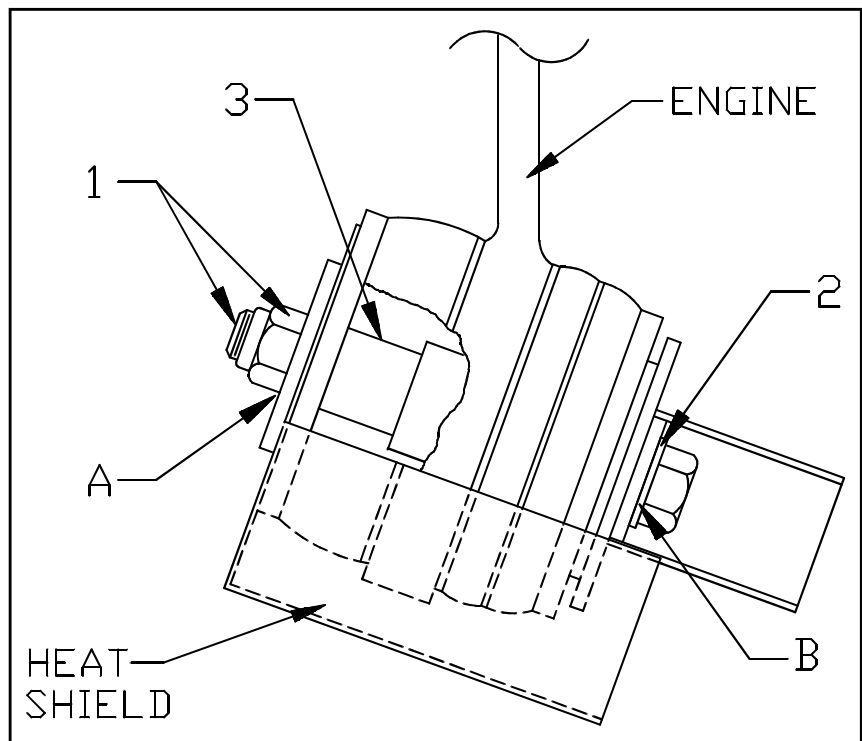
FIGURES/TABLES:  
Figure SI M20-96-1

INTRODUCTION:  
Some M20M aircraft may have the lower engine isolator/mount bolts positioned very close to the engine oil sump. This may create a potential for interference during some operational maneuvers. This Service Instruction repositions the AN960-716 washer from under the nut to under the bolt head, allowing more space between the end of the bolt and the oil sump.

3. Loosen and remove (one side at a time) the two lower isolator/mount attaching hardware (1).
4. Re-position the AN960-716 washer (2) from under nut (forward side of isolator [A]) to under bolt head (aft side of isolator[B]). Do not allow internal spacer (3) to slip out of position during bolt removal.
